# **ARSEE ENGINEERS, INC.**

Johnson Creamery Smokestack  
for

March 1, 2022

Re: Johnson Creamery Smokestack  
Bloomington, Indiana

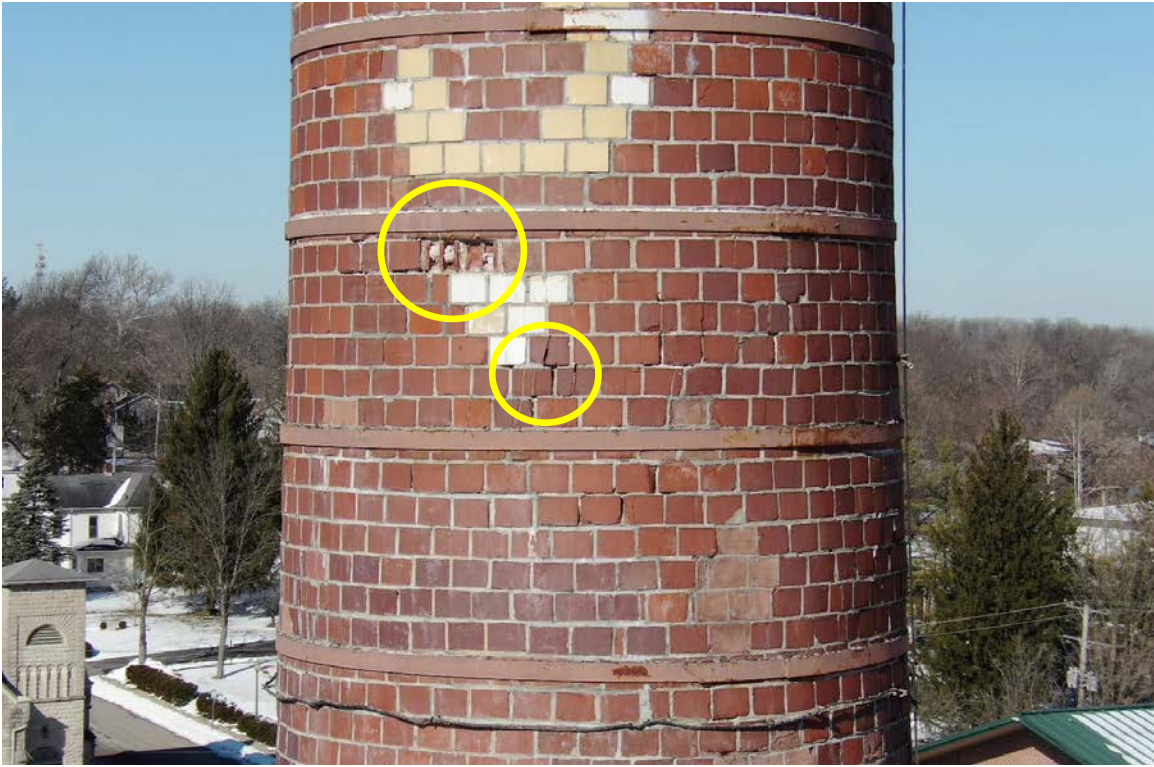
Photo 4 Photo taken in 2022. Band 35 is gone. Remnants of sealant at the top of the band are highlighted as is a new spall.

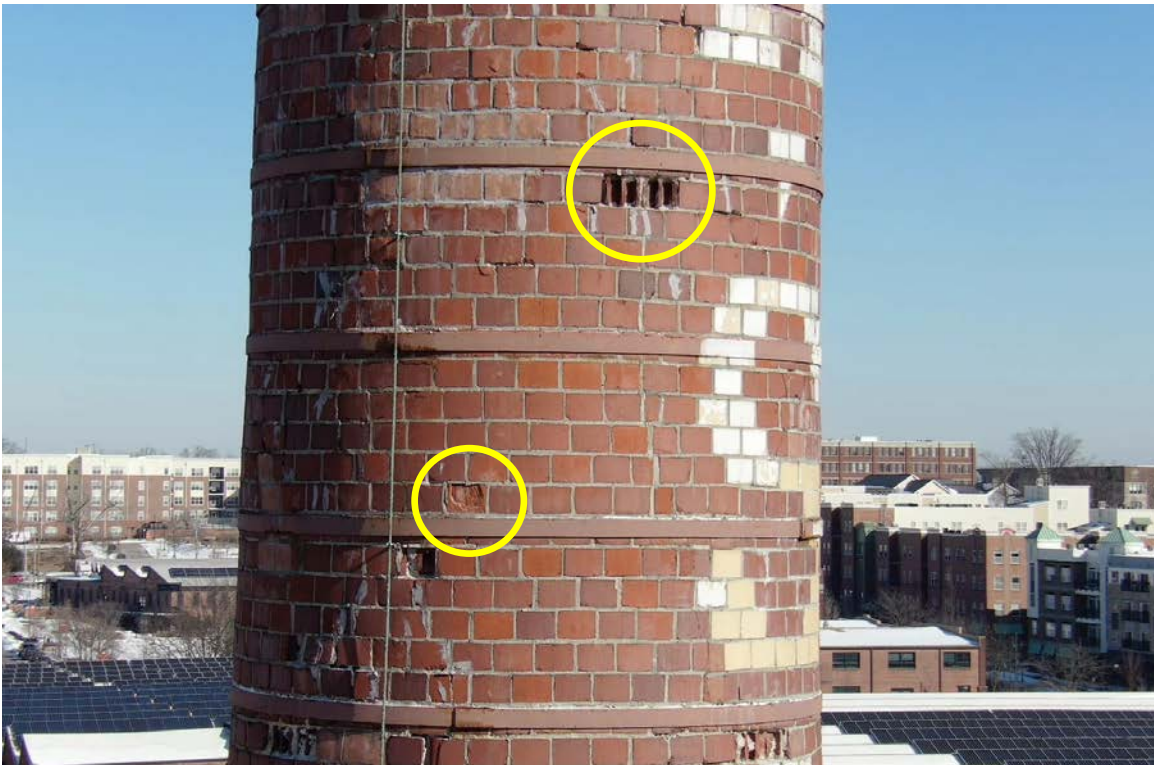
Photo 5 New spalls are highlighted in this 2022 photo.

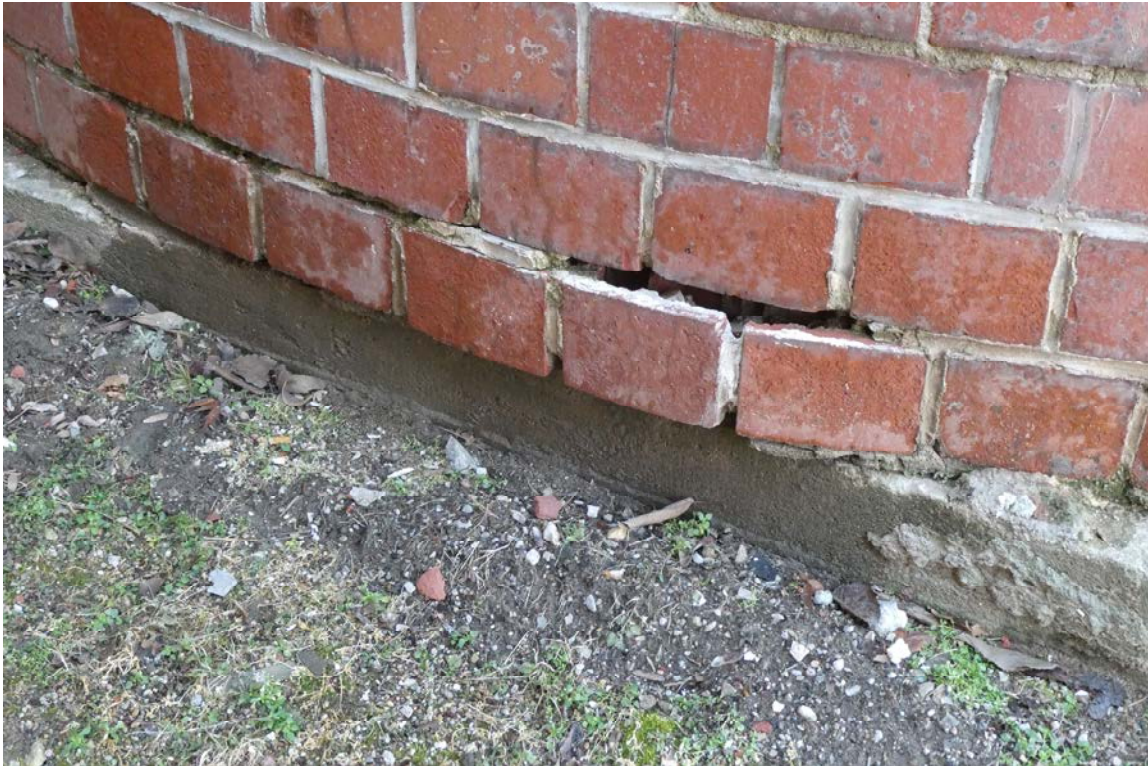
Photo 6 More new spalls are highlighted.

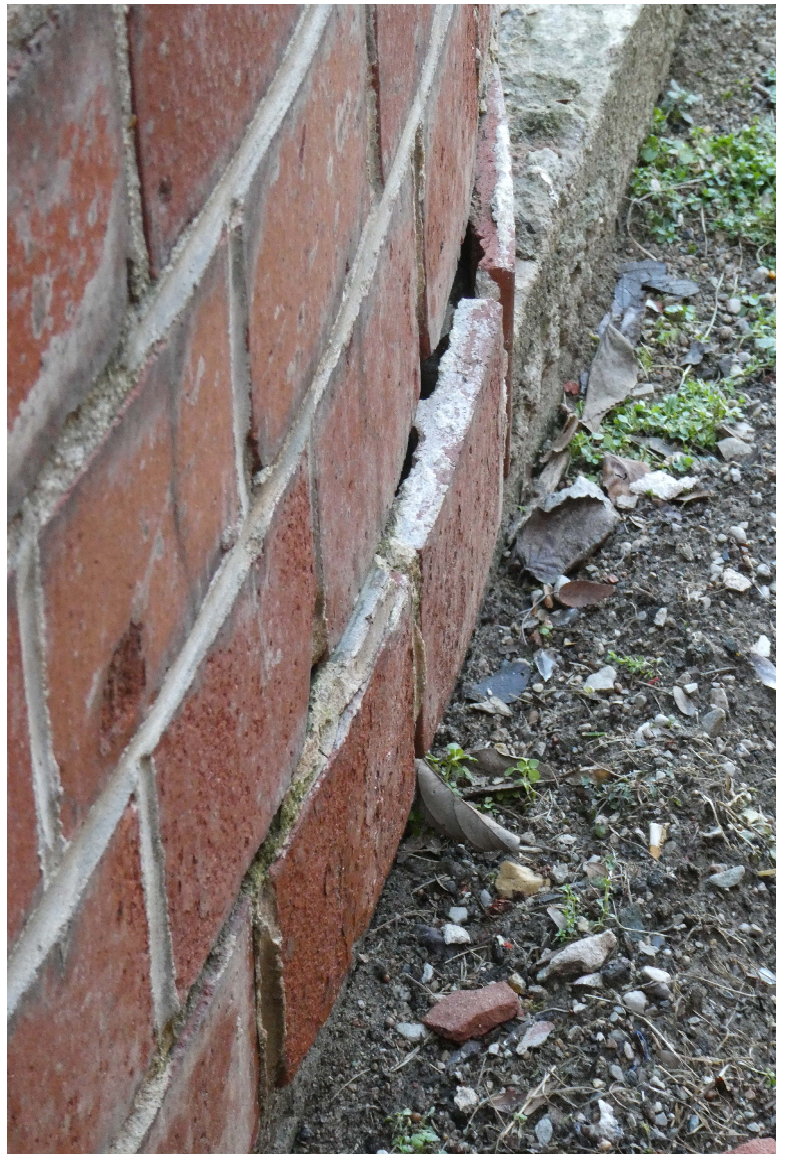
Photo 7  
Spalling extends to the  
base of the stack.

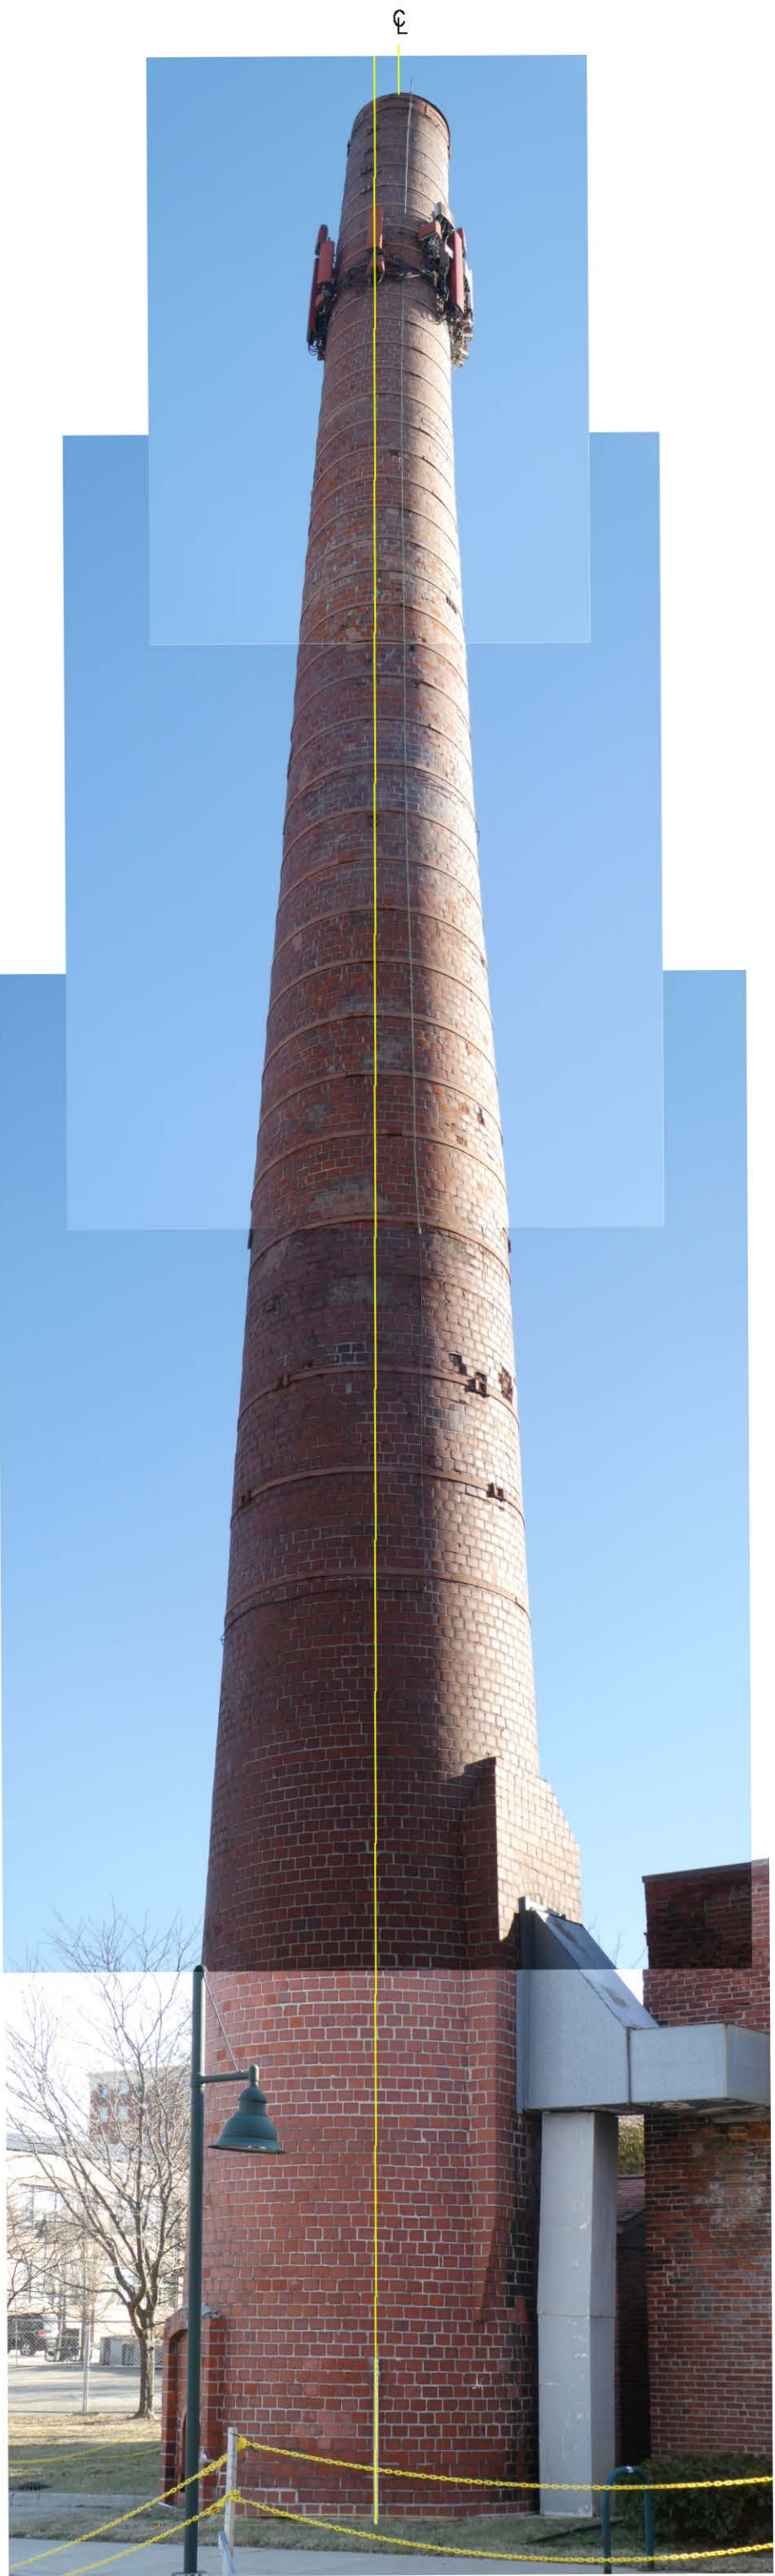
Photo 8  
The face shells are splitting  
off from the body of  
the brick.

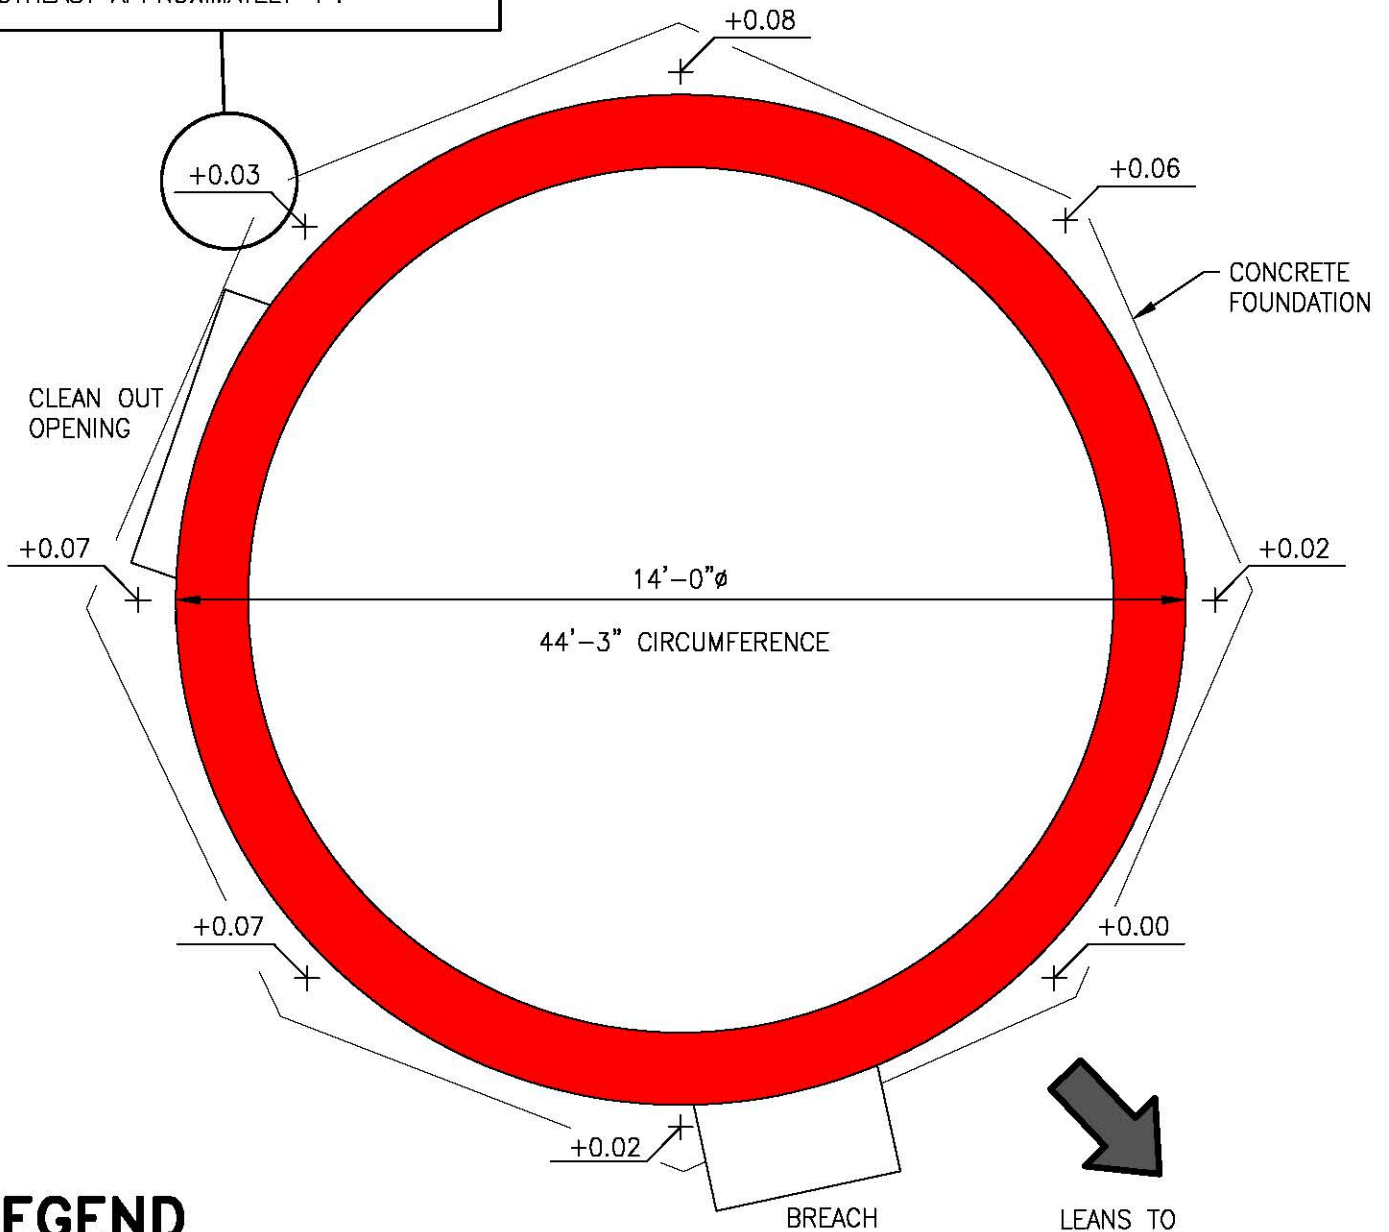
Using a surveying level, elevations were taken at each of the eight corners of the octagonally shaped foundation. While one would not expect a foundation like this to be perfectly level there is a definite trend showing the foundation tilts to the southeast. See Figure 13. A 1 inch tilt in the 14 foot wide foundation corresponds to a 10 inch tilt out of vertical in the 140 foot tall stack. The apparent displacement of the concrete could be result of compression of a mud or clay seam in the bedrock in the southeast portion of the foundation causing it to “tilt” in that direction.

ASSUMING THIS IS AN ANOMALY, THE TOP OF THE FOUNDATION TILTS DOWN TO THE SOUTHEAST APPROXIMATELY 1".

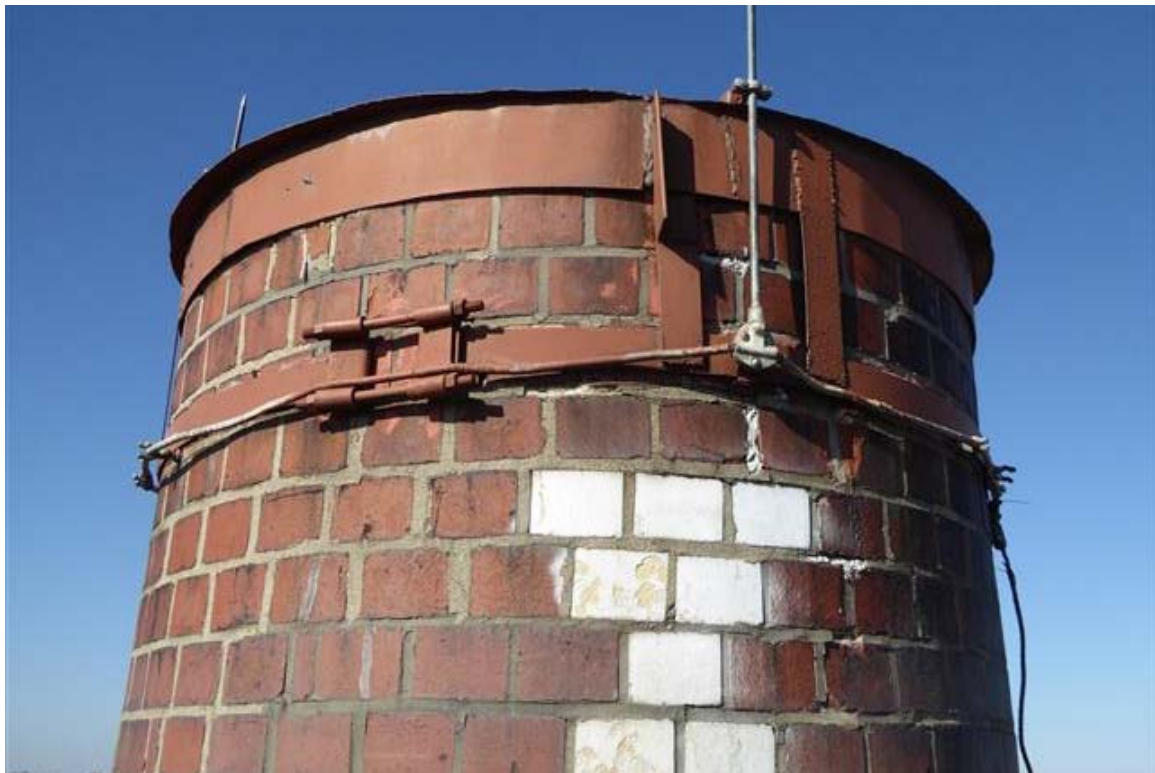
Photo 11 The top of the stack has been capped with a steel plate.

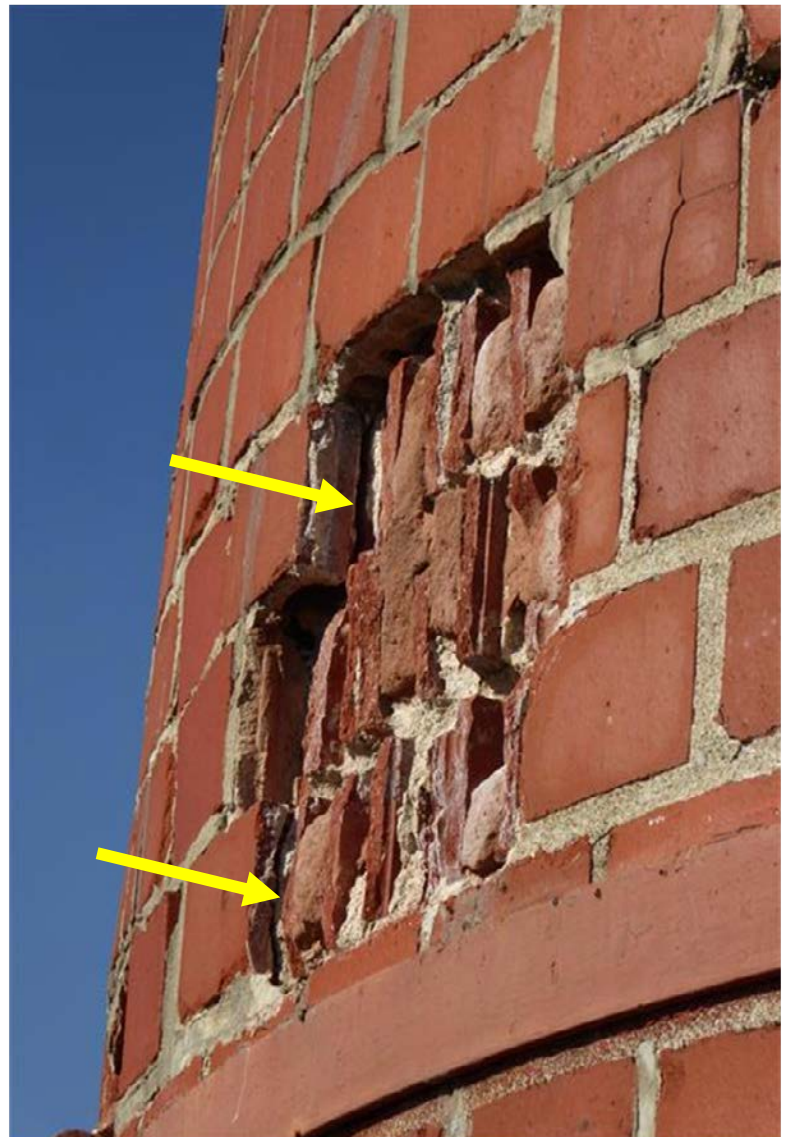
Faces of the brick have spalled in multiple locations.

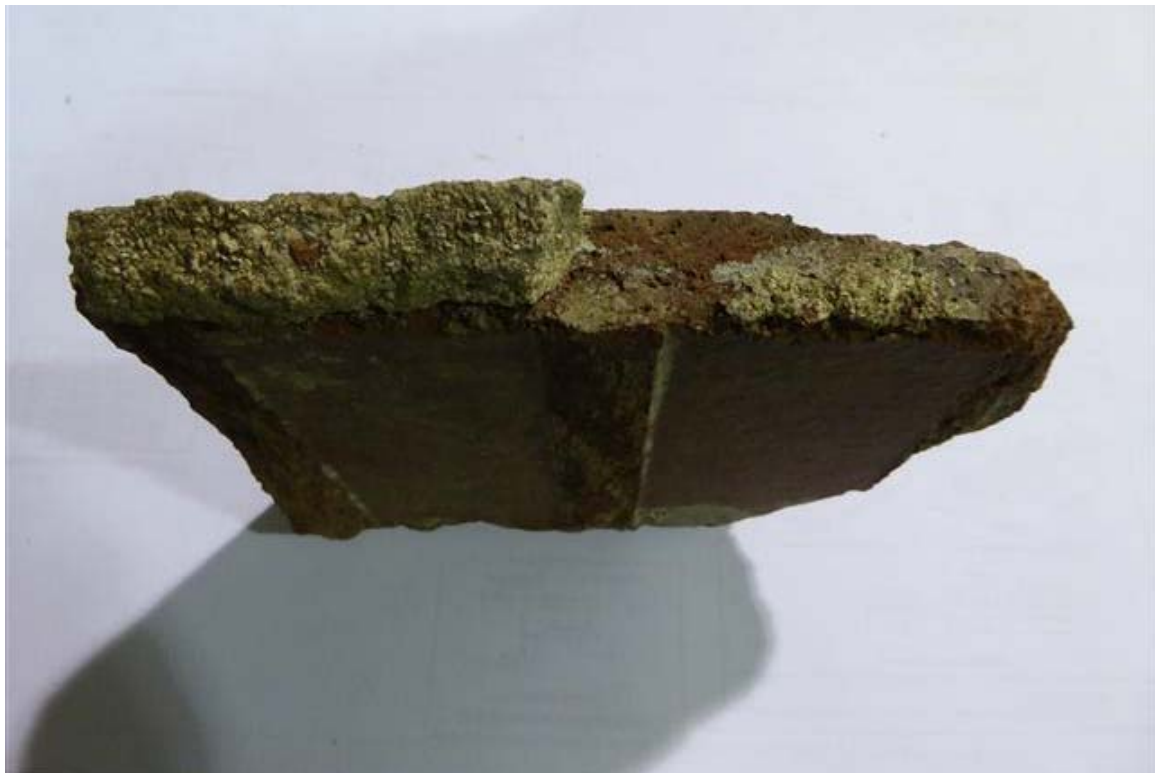
Photo 17 Interior face of a shard found on the ground.

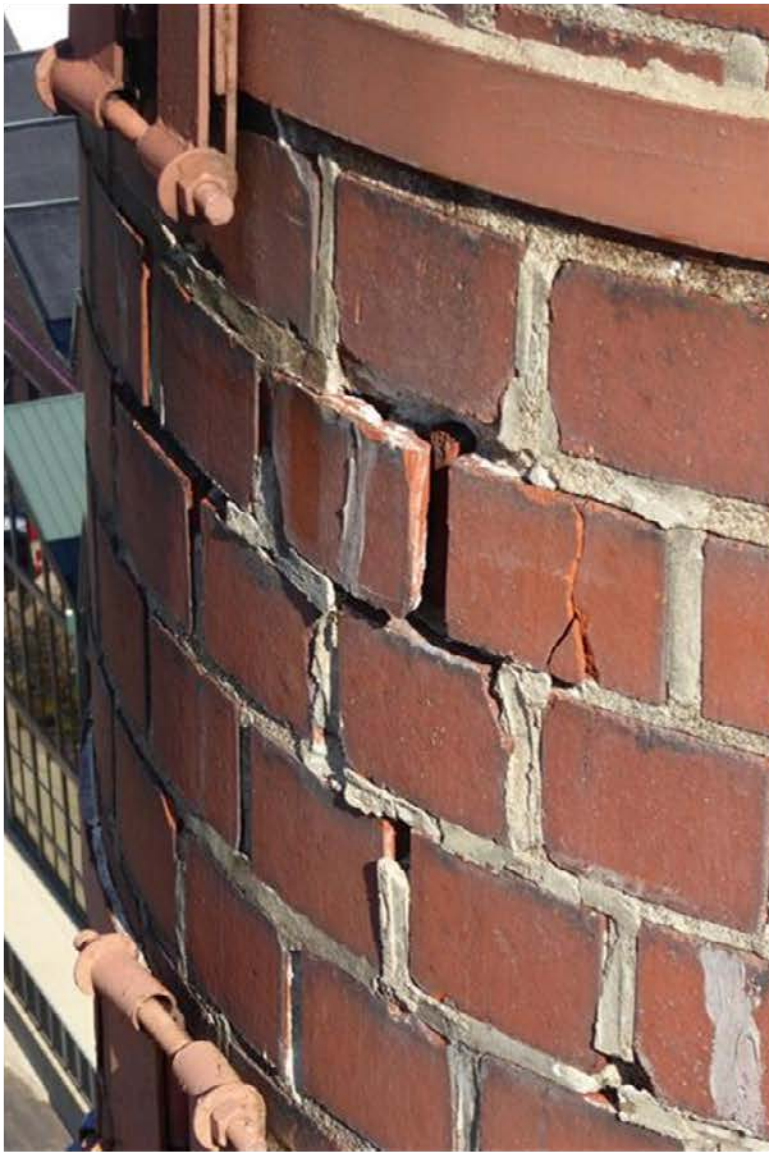
Closer view of these conditions.

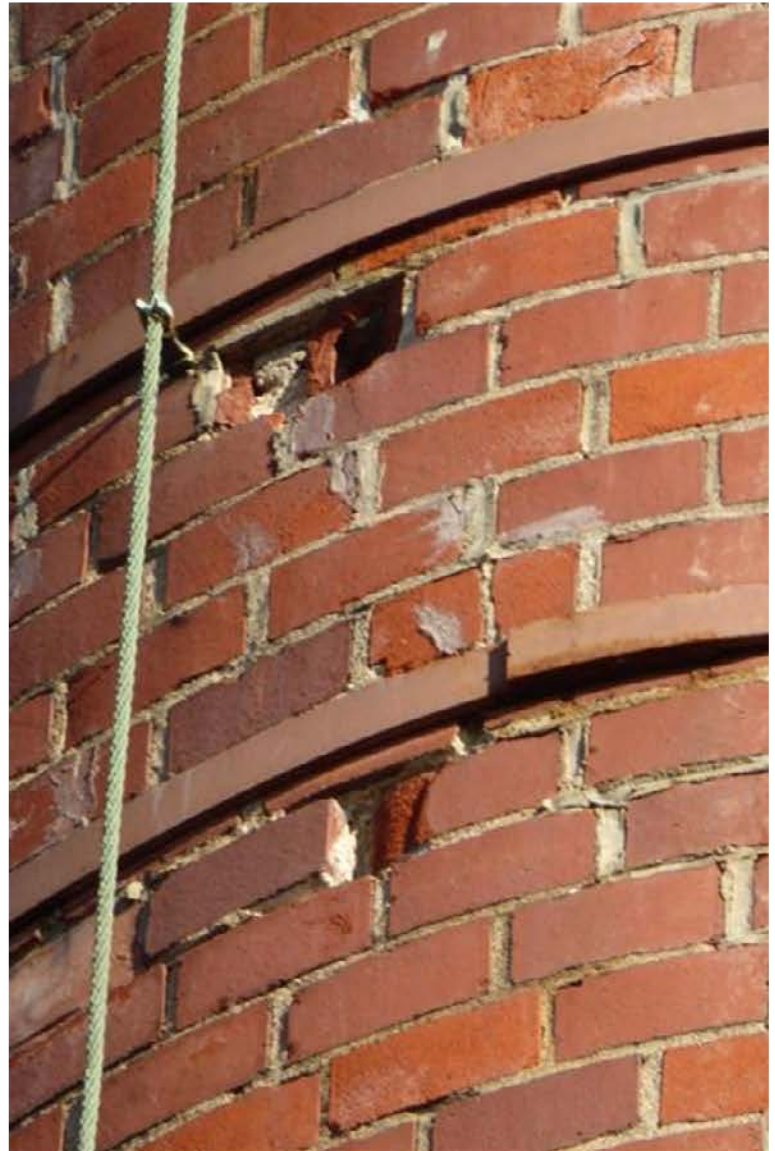
Loose shards of brick up higher in the stack.

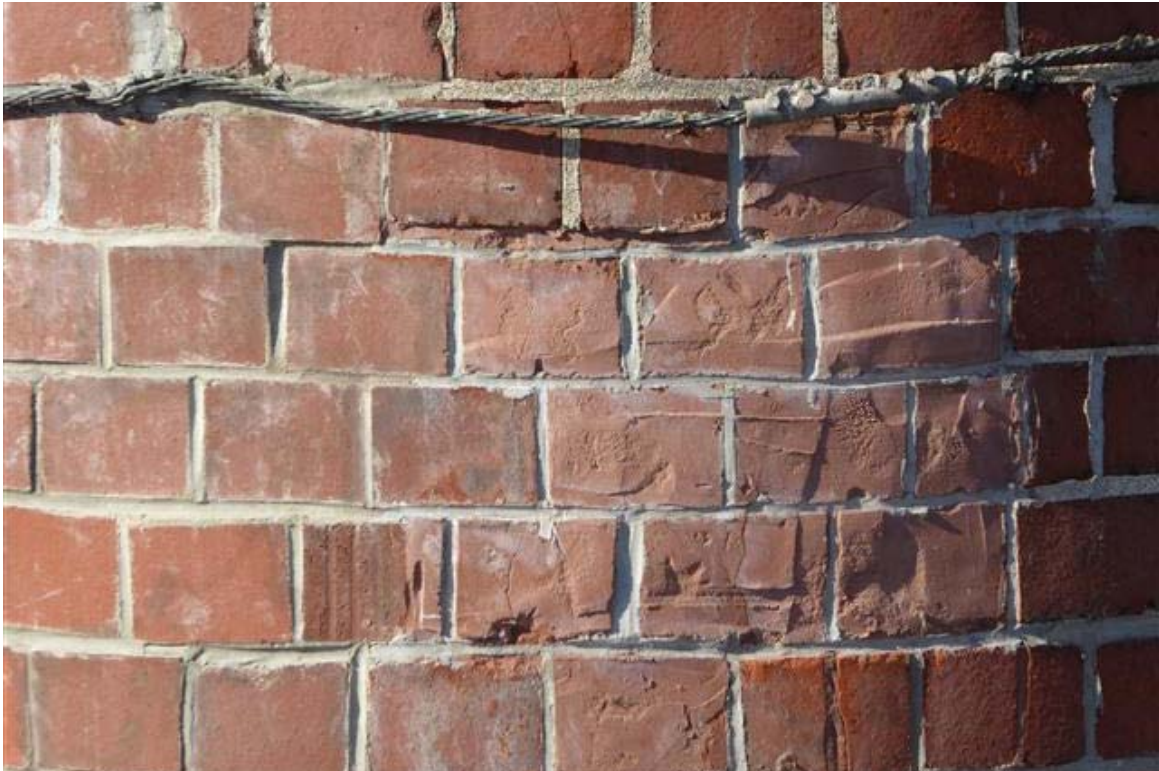
Such shards and spalls occur adjacent to longer vertical and/or stair step cracks.

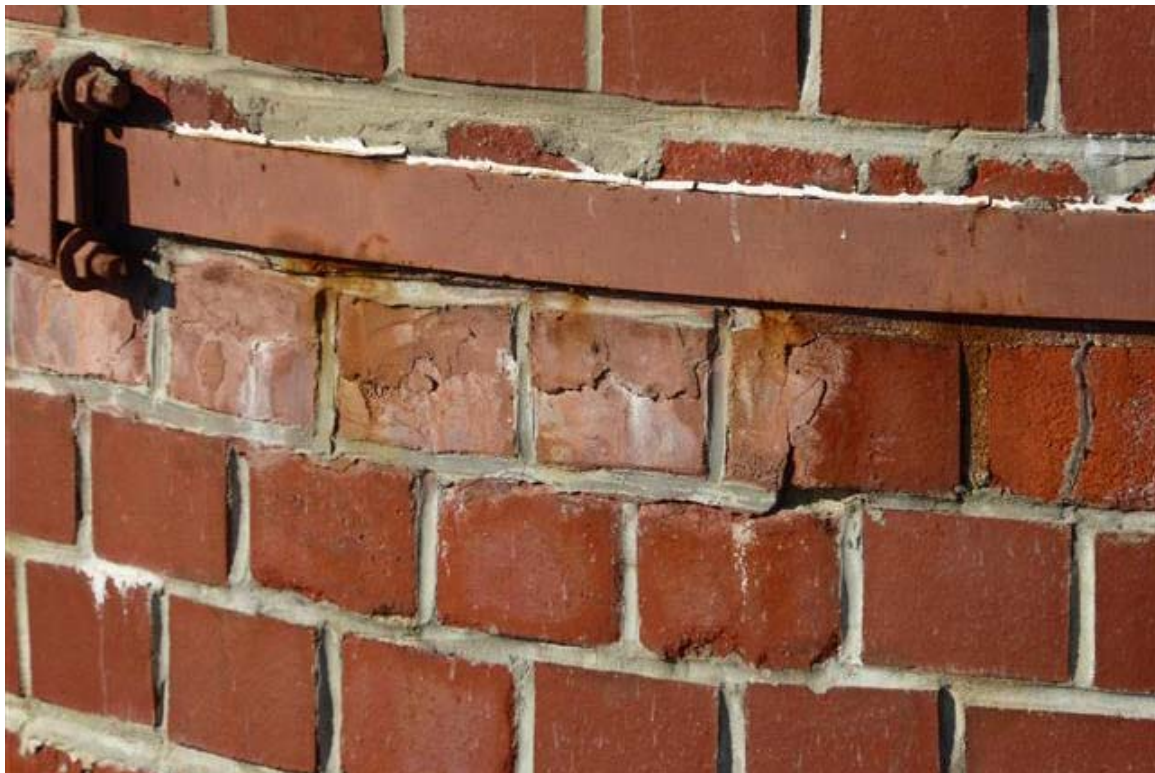
Photo 23 Cementitious patches have been used to replace spalled brick in numerous locations.

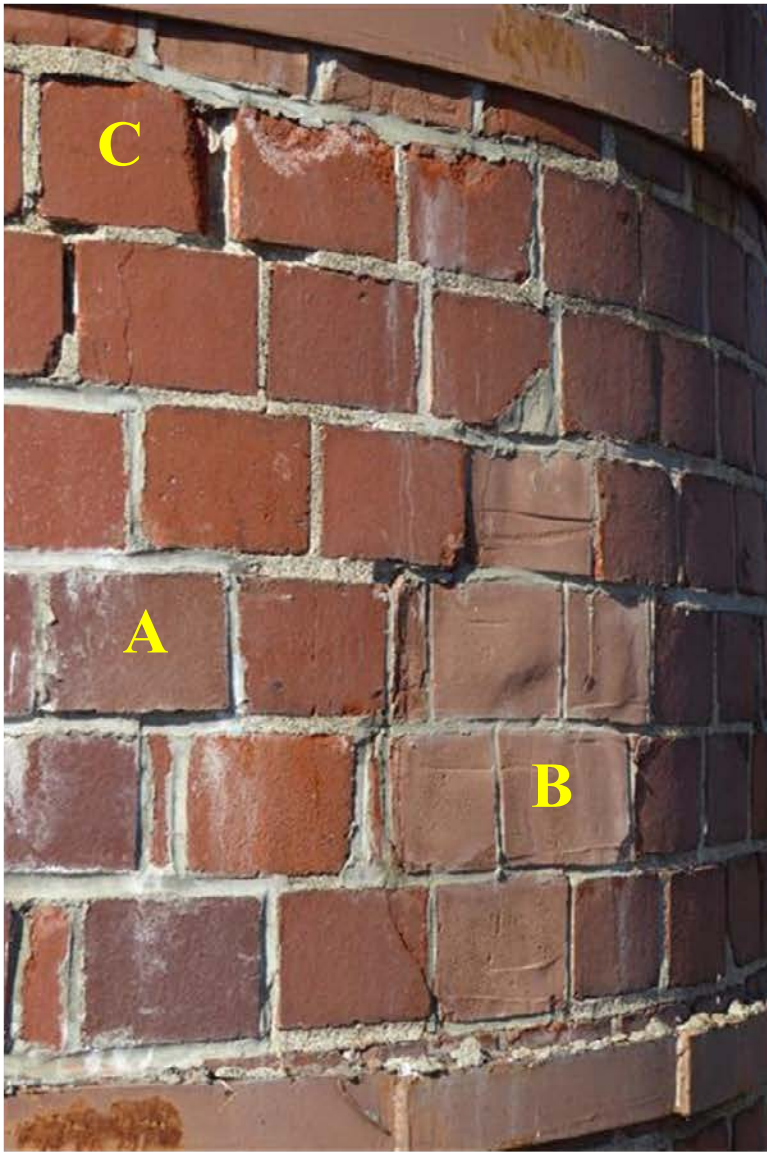
Photo 24 The patching material cracks and falls away itself.

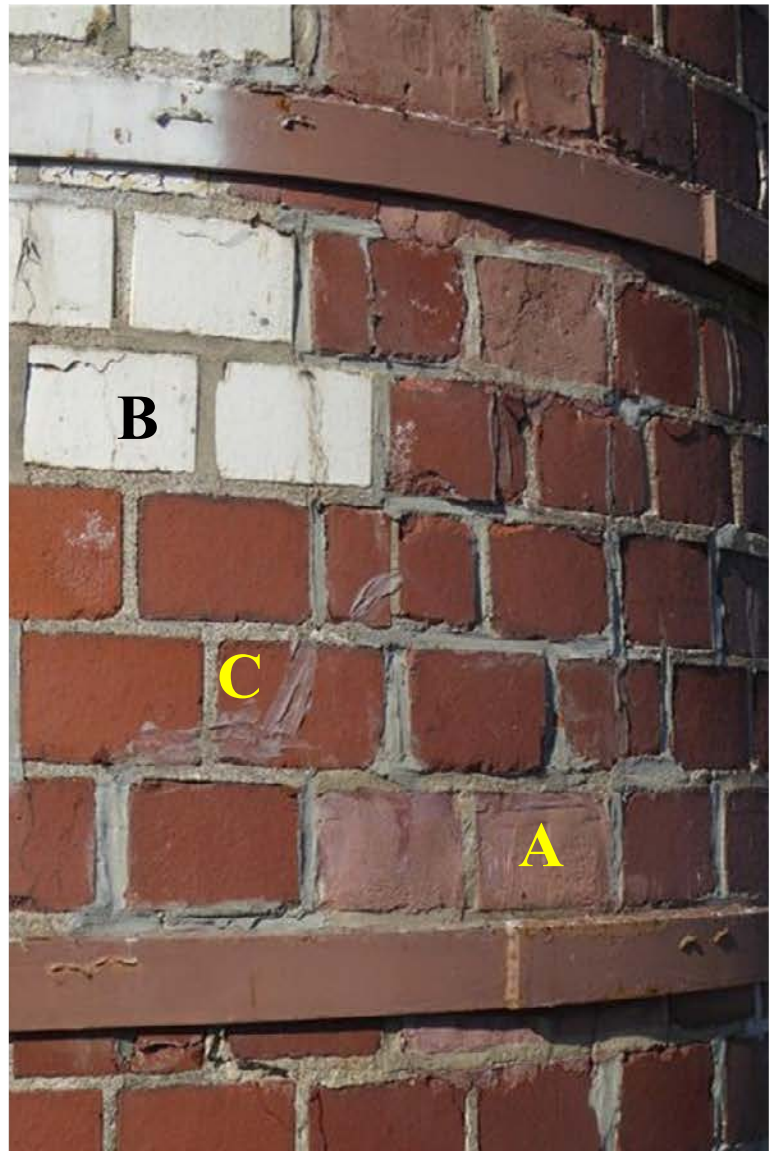
Area where multiple repairs have been made (probably at different times).

A=Brick were replaced with brick  
 B=Brick were patched  
 C=Eroded joints were tuckpointed

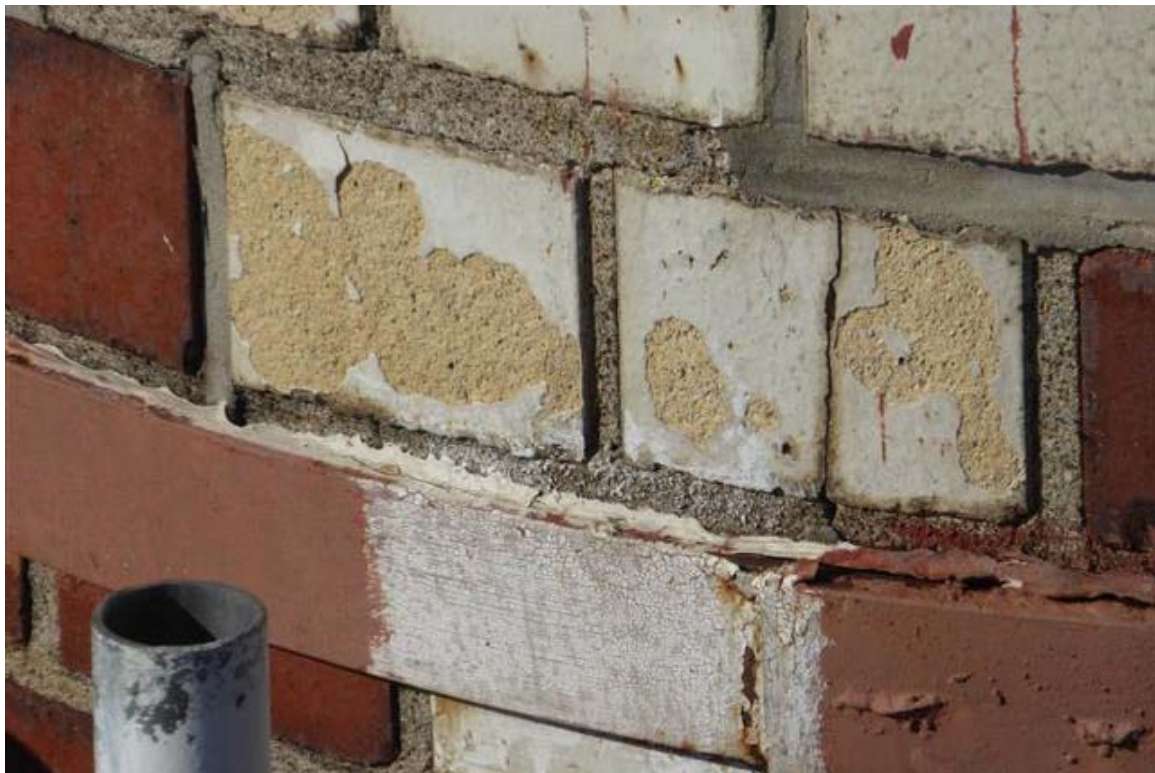
Photo 29 Glaze spalls continue to occur.

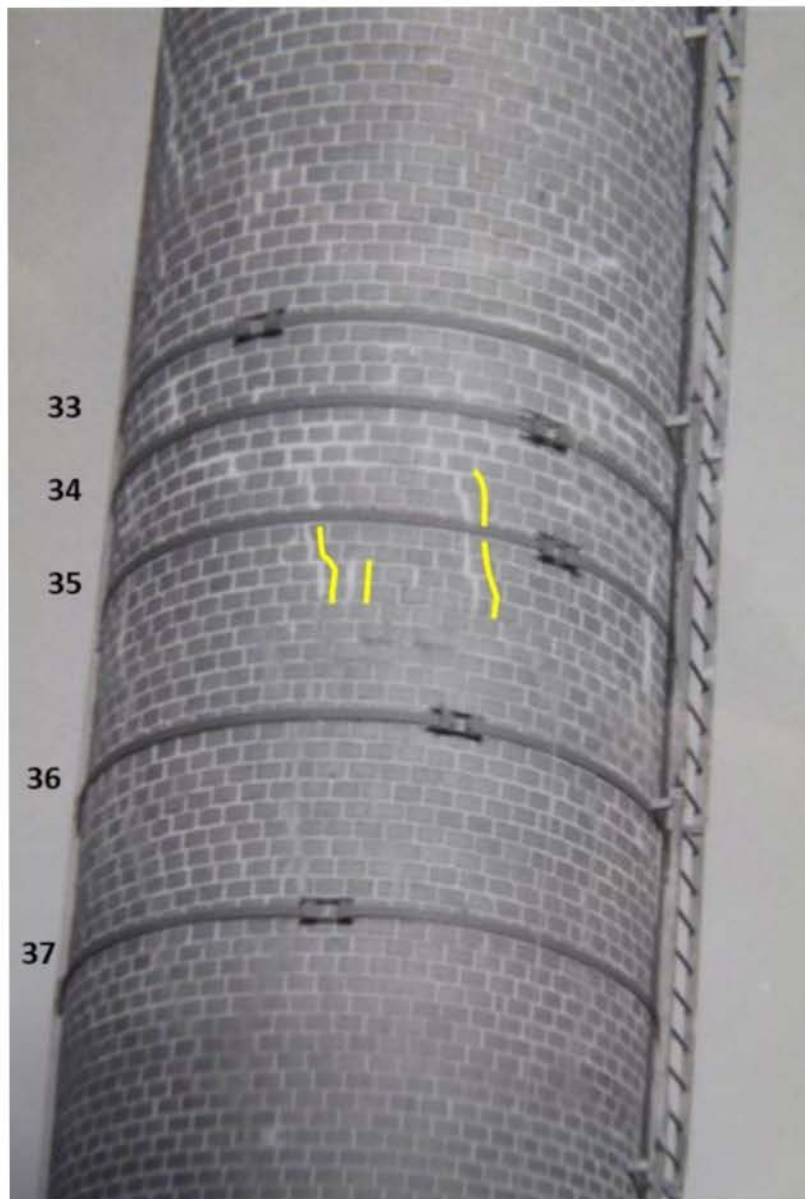
Photo 30 Similar condition in another location.

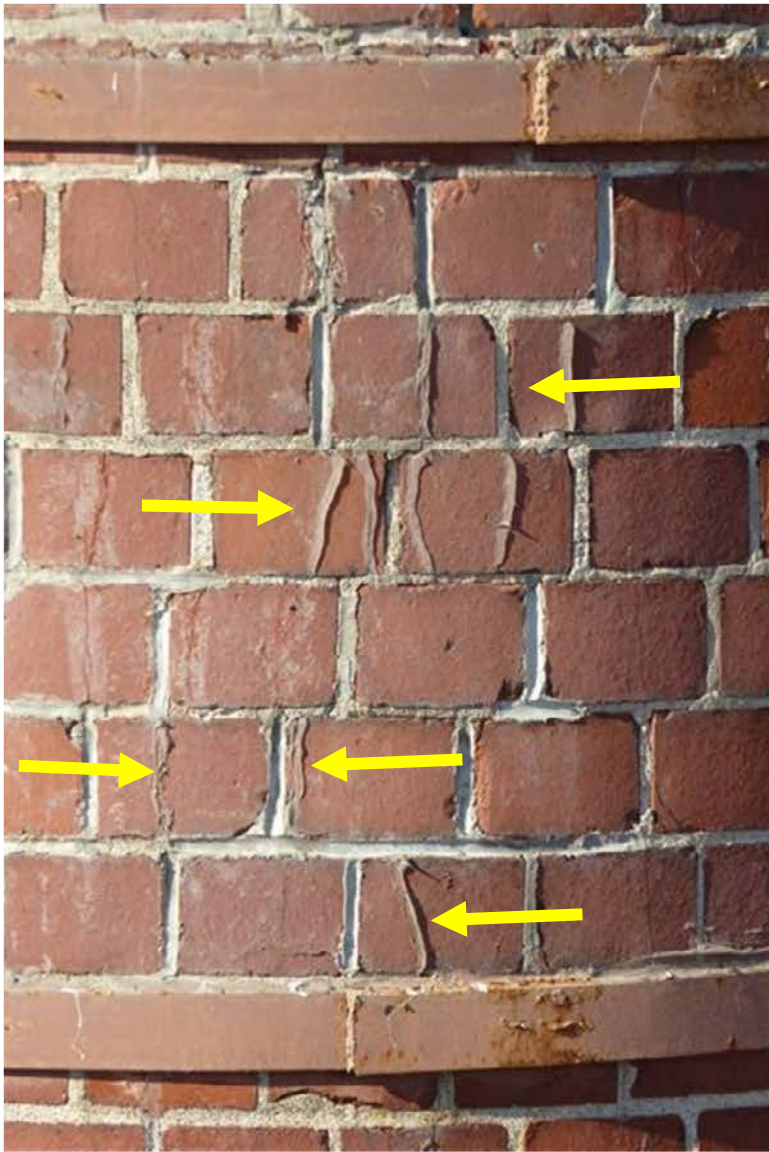
Yet another way of addressing cracks in the masonry.

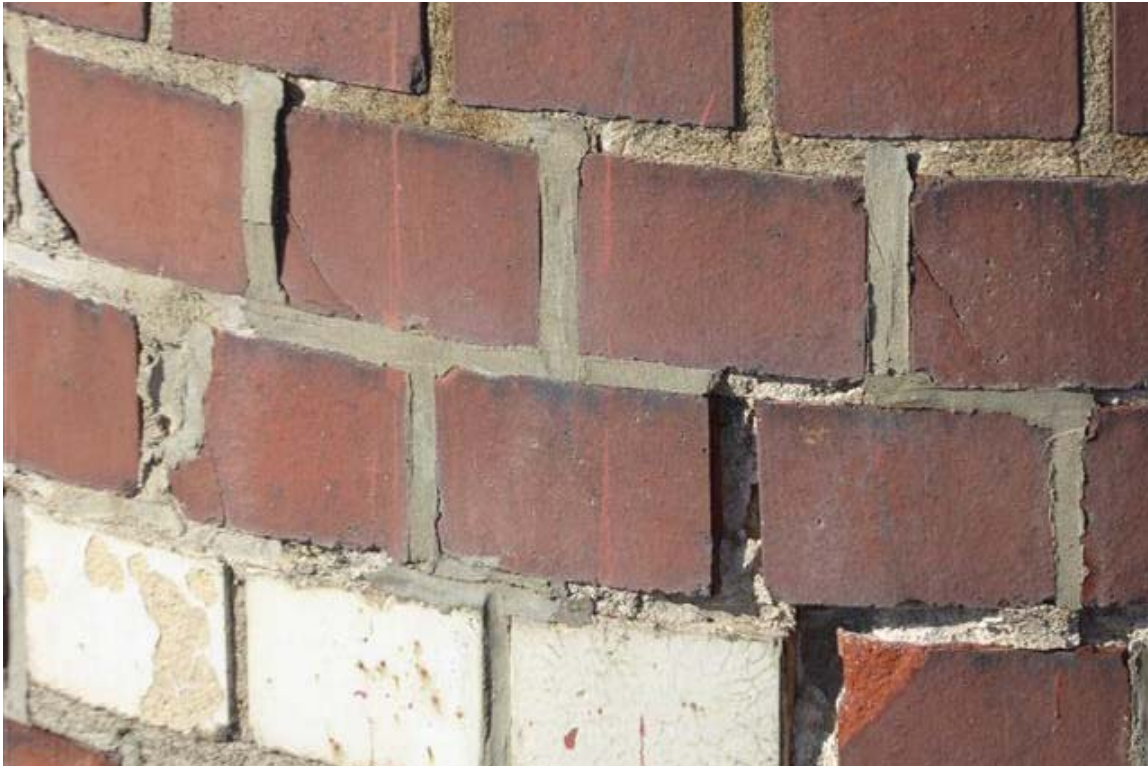
Closer view of one such area.

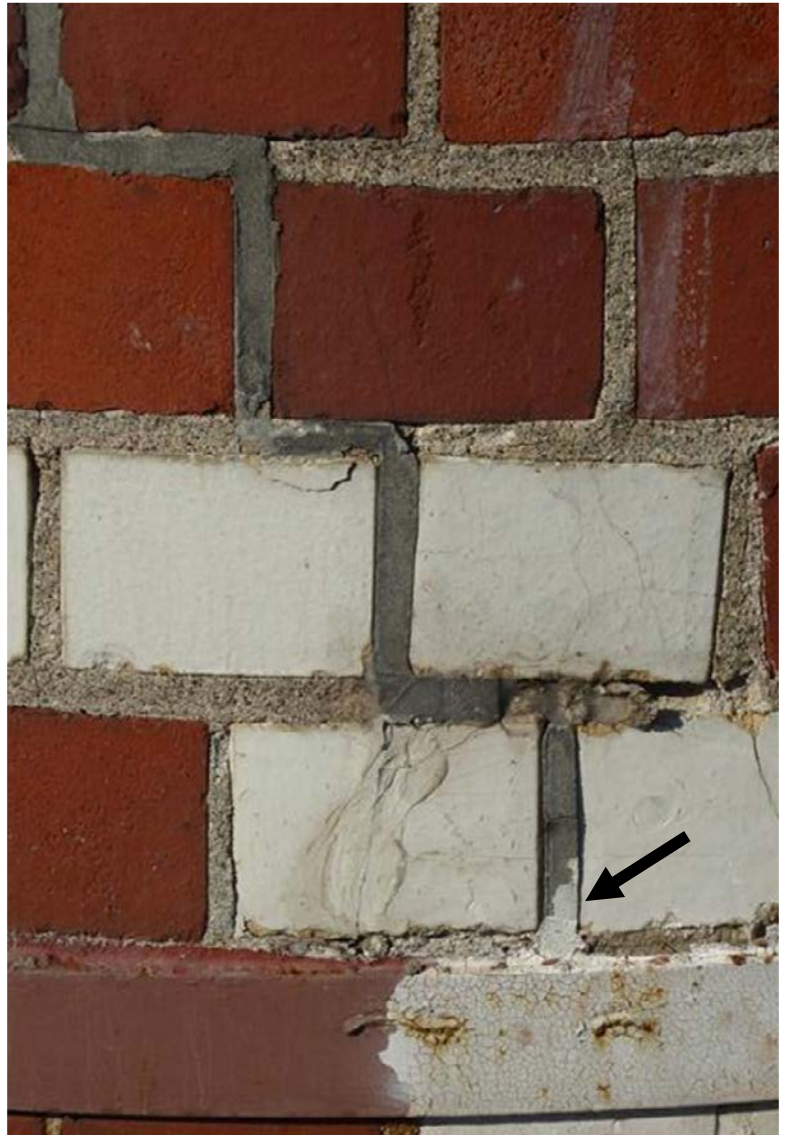
Similar condition in another location.

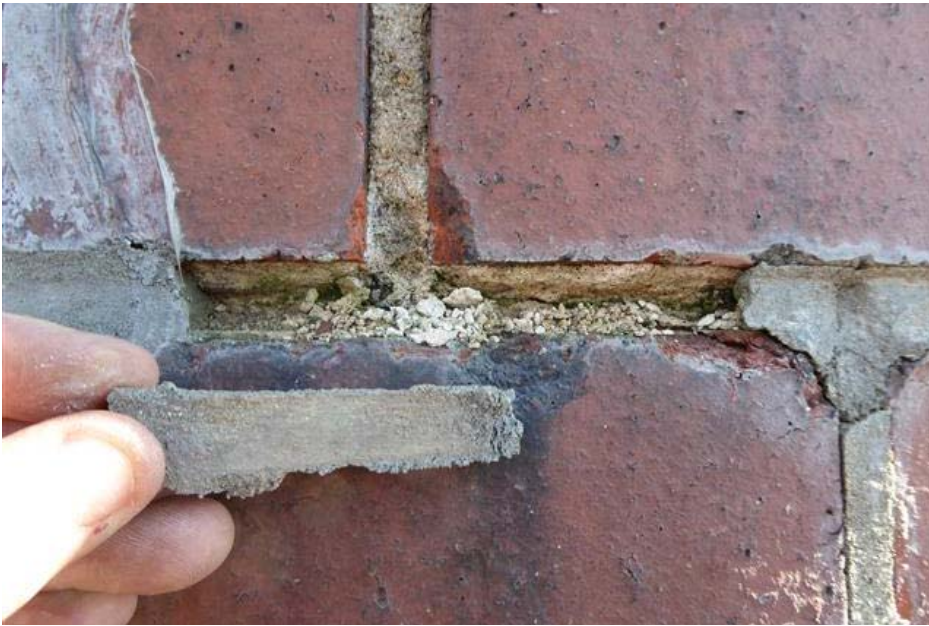
This repair mortar was painted over.
