# **REPORT OF PRELIMINARY GEOTECHNICAL ENGINEERING EXPLORATION**

**MONROE COUNTY JUSTICE CENTER  
BLOOMINGTON, INDIANA**

Re: Report of Preliminary Geotechnical Engineering Exploration  
**Monroe County Justice Center**  
**1510 South Strong Drive**  
**Bloomington, Indiana**  
Patriot Project No.: 23-1415-11G

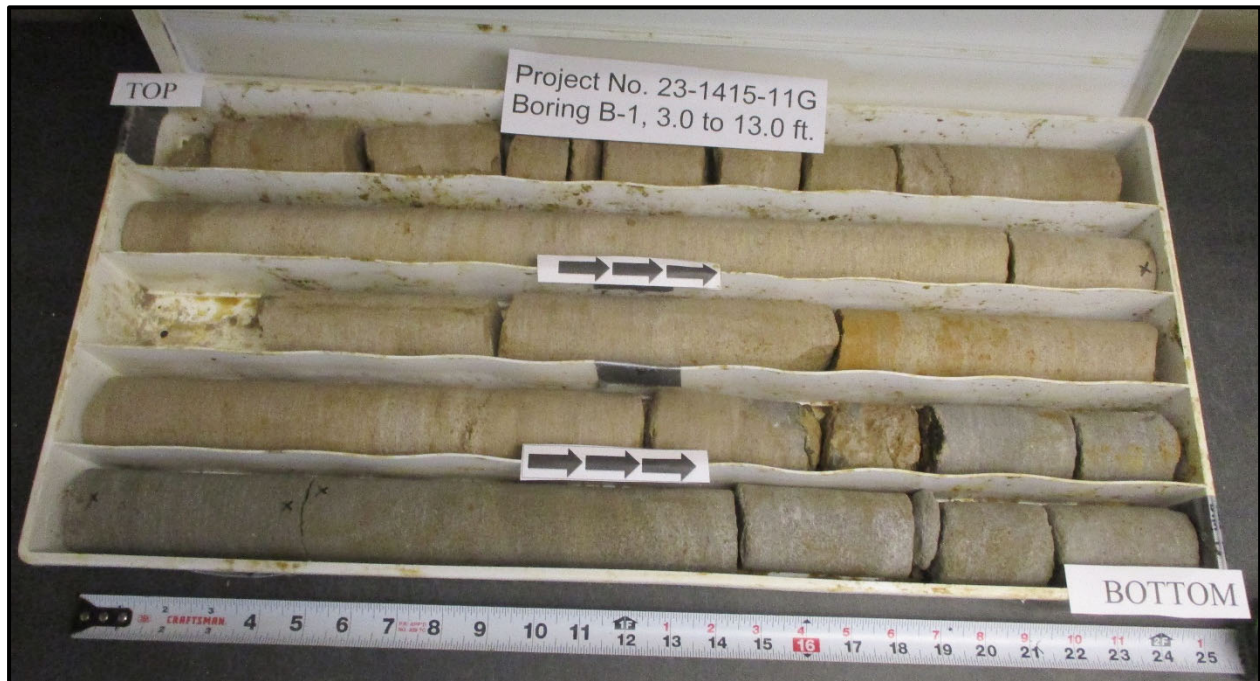
## BORING B-1 (3 TO 13 FEET)

BORING NUMBER	ROCK CORE DEPTH (feet) <sup>(1)</sup>	RQD (%)	UNCONFINED COMPRESSIVE STRENGTH (psi)
B-1	3 TO 8	53	4,830
	8 TO 13	62	4,290

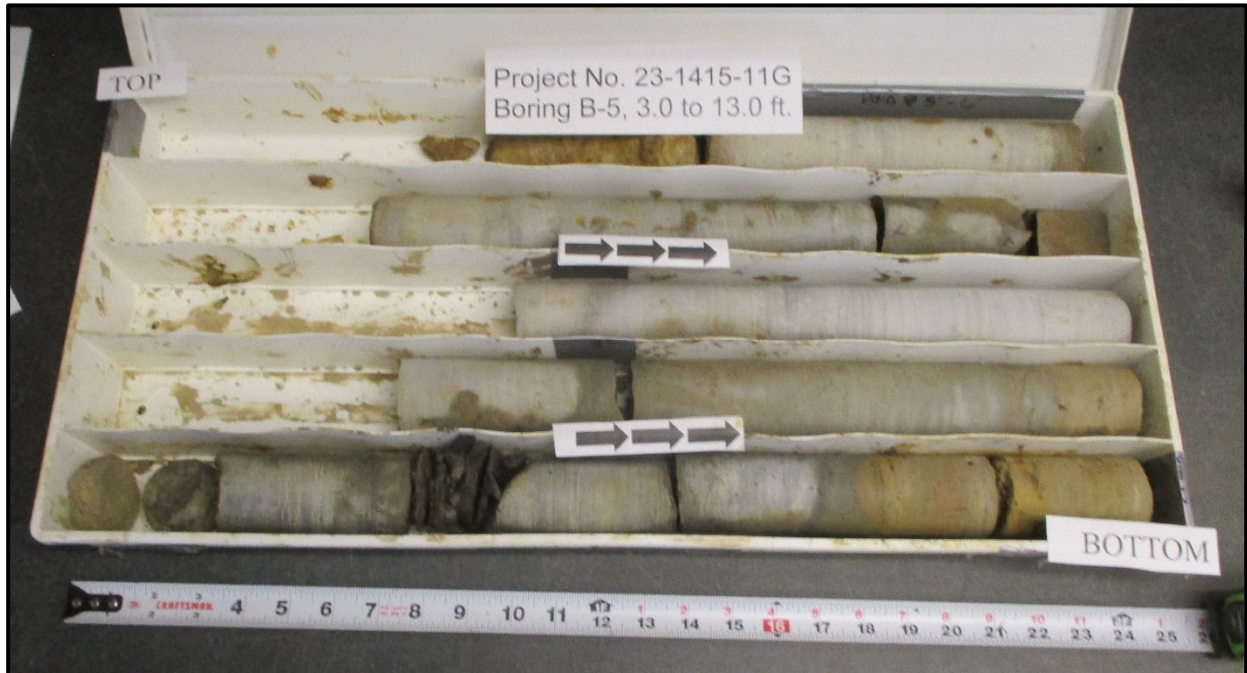
## BORING B-5 (3 TO 13 FEET)

Open voids in bedrock was encountered in one boring (Boring B-5), about 2 feet below the surface of rock and observed to be about 1 foot in length. In addition, a clay seams was encountered in one boring (Boring B-6) about 1 foot below the surface of rock and observed to be about ½ foot in length.

BORING NUMBER	ROCK CORE DEPTH (feet) <sup>(1)</sup>	RQD (%)	UNCONFINED COMPRESSIVE STRENGTH (psi)
B-5	3 TO 8	25	11,410
	8 TO 13	37	20,530

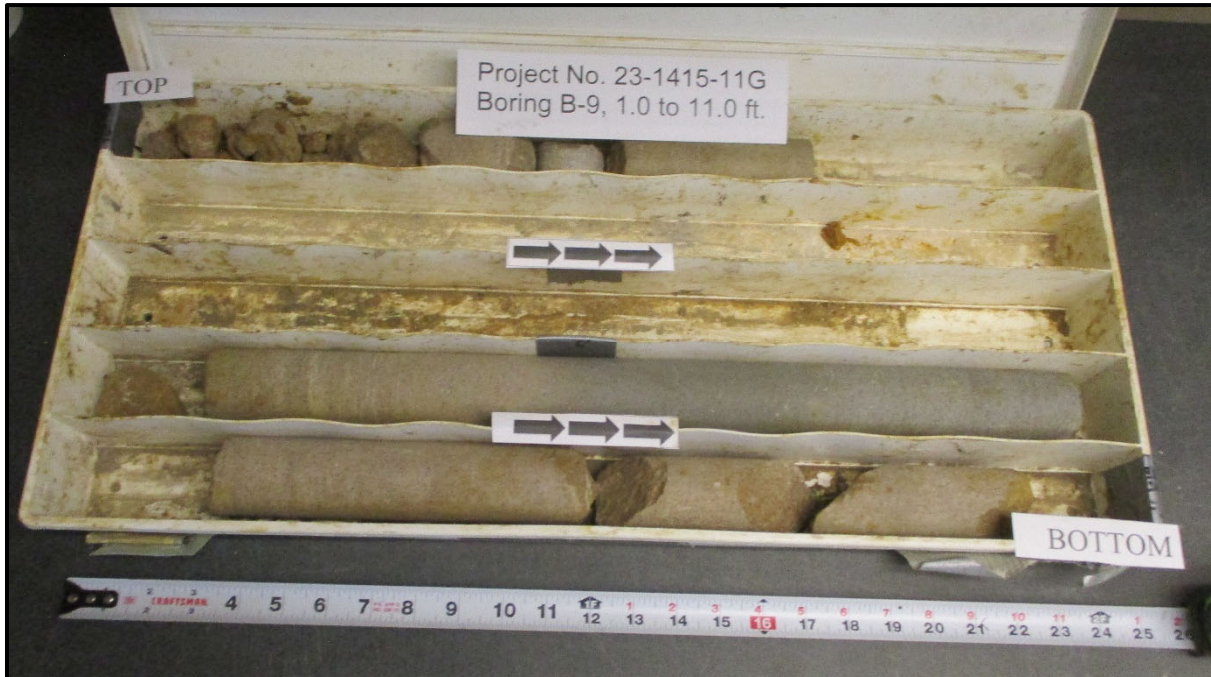
## BORING B-9 (1 TO 11 FEET)

BORING NUMBER	ROCK CORE DEPTH (feet) <sup>(1)</sup>	RQD (%)	UNCONFINED COMPRESSIVE STRENGTH (psi)
B-9	1 TO 6	7	6,110
	6 TO 11	44	8,230

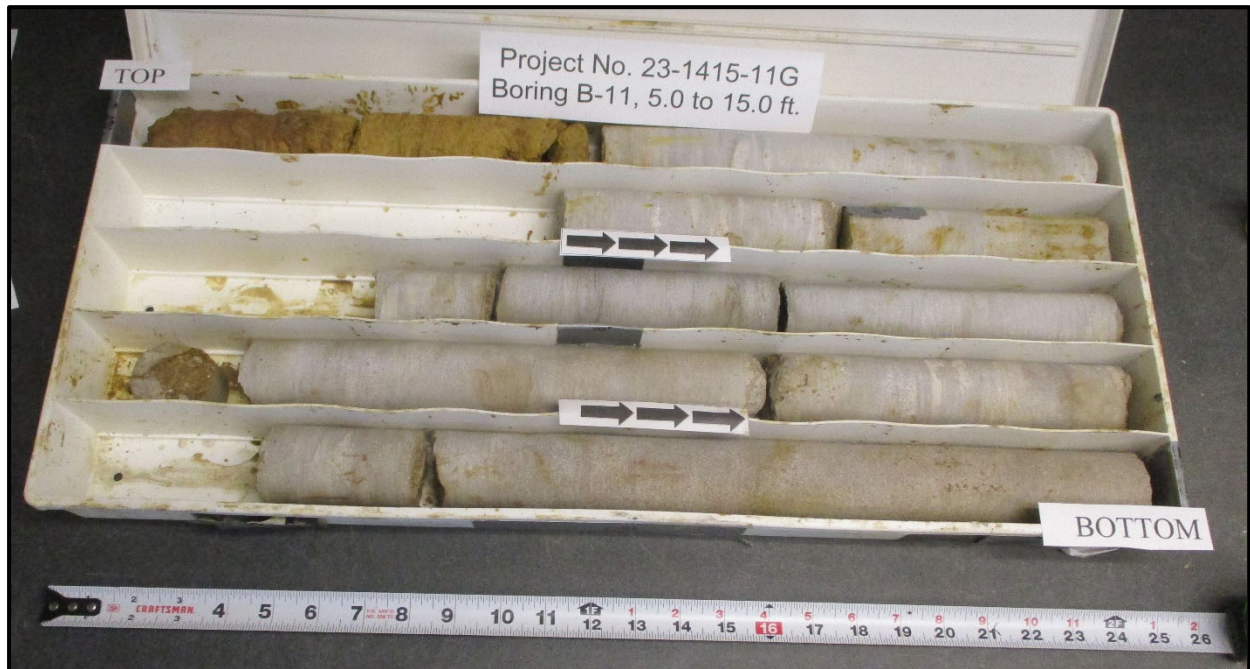
## BORING B-11 (5 TO 15 FEET)

BORING NUMBER	ROCK CORE DEPTH (feet) <sup>(1)</sup>	RQD (%)	UNCONFINED COMPRESSIVE STRENGTH (psi)
B-11	5 TO 10	48	15,510
	10 TO 15	75	11,290

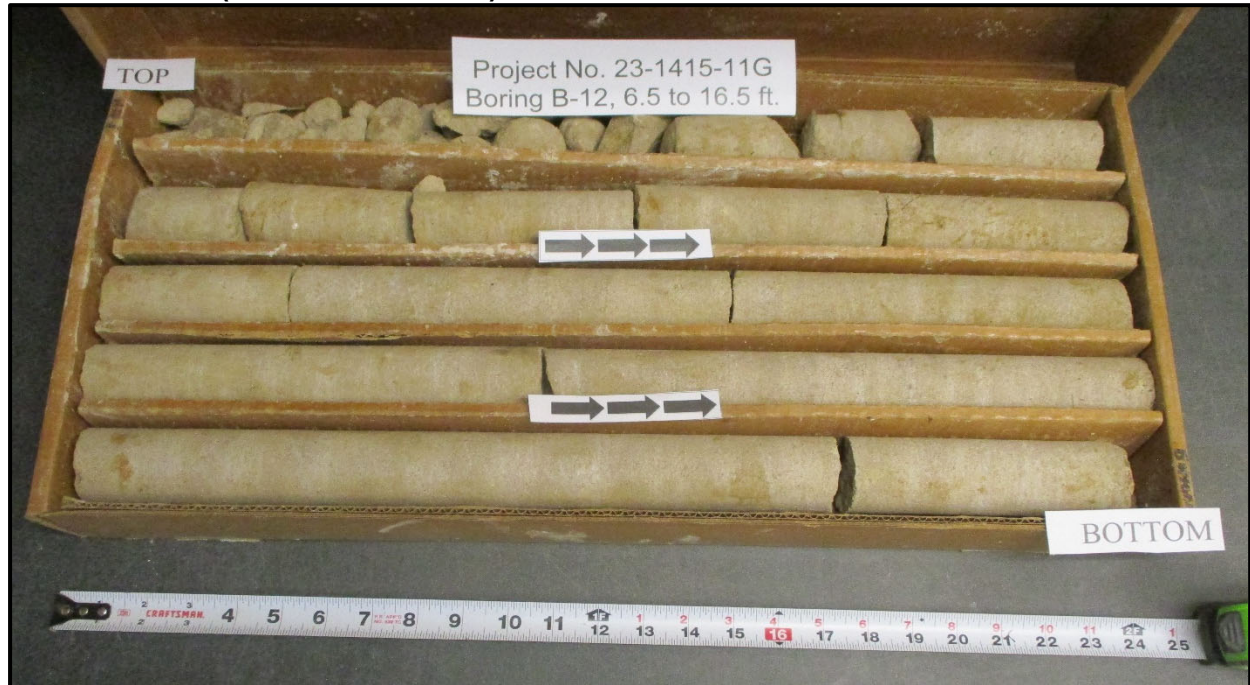
## BORING B-12 (6.5 TO 16.5 FEET)

BORING NUMBER	ROCK CORE DEPTH (feet) <sup>(1)</sup>	RQD (%)	UNCONFINED COMPRESSIVE STRENGTH (psi)
B-12	6.5 TO 11.5	35	3,820
	11.5 TO 16.5	87	3,360

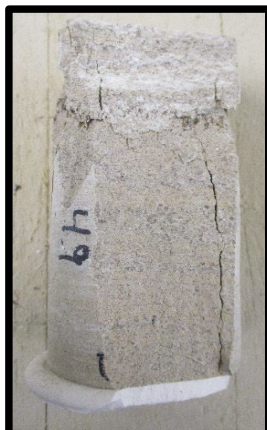
Project Name	Monroe County Justice Center
Project No.	23-1415-11G
Client	Monroe County Commissioners
Boring No.	B-1
Sample No.	S-2
Sample Depth, (ft)	4.6-4.9
Lithologic Sample Description	Gray, slightly weathered, LIMESTONE
Load Direction (with respect to lithology)	Vertical
Moisture Condition at Time of Test	As-Received
Average Diameter (in)	1.838
Average Length (in)	3.927
Mass (g)	371.1
Conforms to ASTM D4543 Dimensional Requirements? If no, explain.	Specimen capped with Gypsum Capping Compound due to irregularities on the end surfaces
Temperature at Time of Test (°C)	20.1
Loading Rate (lb/sec)	100
Time to Failure (min)	4
Failure Load, (lb)	12,820
Uniaxial Compressive Strength, (psi)	4,830
Uniaxial Compressive Strength, (tsf)	348
Description of Specimen After Test	See Photograph Below
Tested by/ Date	V. Bump 10/17/2023
Reviewed by / Date	J. Rogers 10/24/2023

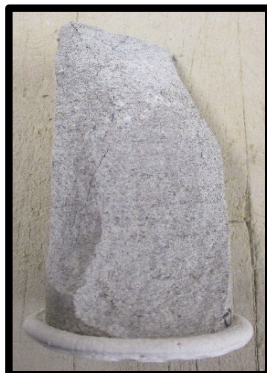
Project Name	Monroe County Justice Center
Project No.	23-1415-11G
Client	Monroe County Commissioners
Boring No.	B-1
Sample No.	S-3
Sample Depth, (ft)	11-11.3
Lithologic Sample Description	Gray, slightly weathered, LIMESTONE
Load Direction (with respect to lithology)	Vertical
Moisture Condition at Time of Test	As-Received
Average Diameter (in)	1.849
Average Length (in)	3.897
Mass (g)	382.3
Conforms to ASTM D4543 Dimensional Requirements? If no, explain.	Specimen capped with Gypsum Capping Compound due to irregularities on the end surfaces
Temperature at Time of Test (°C)	20.1
Loading Rate (lb/sec)	100
Time to Failure (min)	3
Failure Load, (lb)	11,530
Uniaxial Compressive Strength, (psi)	4,290
Uniaxial Compressive Strength, (tsf)	309
Description of Specimen After Test	See Photograph Below
Tested by/ Date	V. Bump 10/17/2023
Reviewed by / Date	J. Rogers 10/24/2023

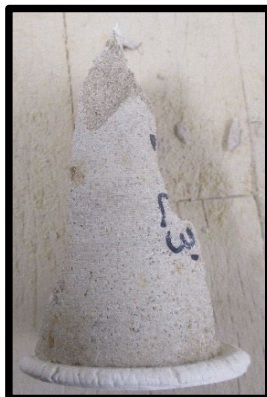
Project Name	Monroe County Justice Center
Project No.	23-1415-11G
Client	Monroe County Commissioners
Boring No.	B-9
Sample No.	S-1
Sample Depth, (ft)	2-2.3
Lithologic Sample Description	Gray, moderately to slightly weathered, LIMESTONE
Load Direction (with respect to lithology)	Vertical
Moisture Condition at Time of Test	As-Received
Average Diameter (in)	1.847
Average Length (in)	3.840
Mass (g)	388.1
Conforms to ASTM D4543 Dimensional Requirements? If no, explain.	Specimen capped with Gypsum Capping Compound due to irregularities on the end surfaces
Temperature at Time of Test (°C)	20.3
Loading Rate (lb/sec)	100
Time to Failure (min)	4
Failure Load, (lb)	16,370
Uniaxial Compressive Strength, (psi)	6,110
Uniaxial Compressive Strength, (tsf)	440
Description of Specimen After Test	See Photograph Below
Tested by/ Date	V. Bump 10/17/2023
Reviewed by / Date	J. Rogers 10/24/2023

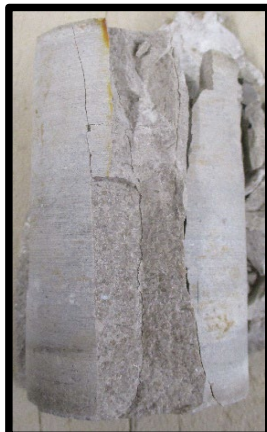
Project Name	Monroe County Justice Center
Project No.	23-1415-11G
Client	Monroe County Commissioners
Boring No.	B-11
Sample No.	S-4
Sample Depth, (ft)	12.3-12.6
Lithologic Sample Description	Gray, slightly weathered, LIMESTONE
Load Direction (with respect to lithology)	Vertical
Moisture Condition at Time of Test	As-Received
Average Diameter (in)	1.846
Average Length (in)	3.953
Mass (g)	423.0
Conforms to ASTM D4543 Dimensional Requirements? If no, explain.	Specimen capped with Gypsum Capping Compound due to irregularities on the end surfaces
Temperature at Time of Test (°C)	20.5
Loading Rate (lb/sec)	100
Time to Failure (min)	7
Failure Load, (lb)	30,210
Uniaxial Compressive Strength, (psi)	11,290
Uniaxial Compressive Strength, (tsf)	813
Description of Specimen After Test	See Photograph Below
Tested by/ Date	V. Bump 10/17/2023
Reviewed by / Date	J. Rogers 10/24/2023

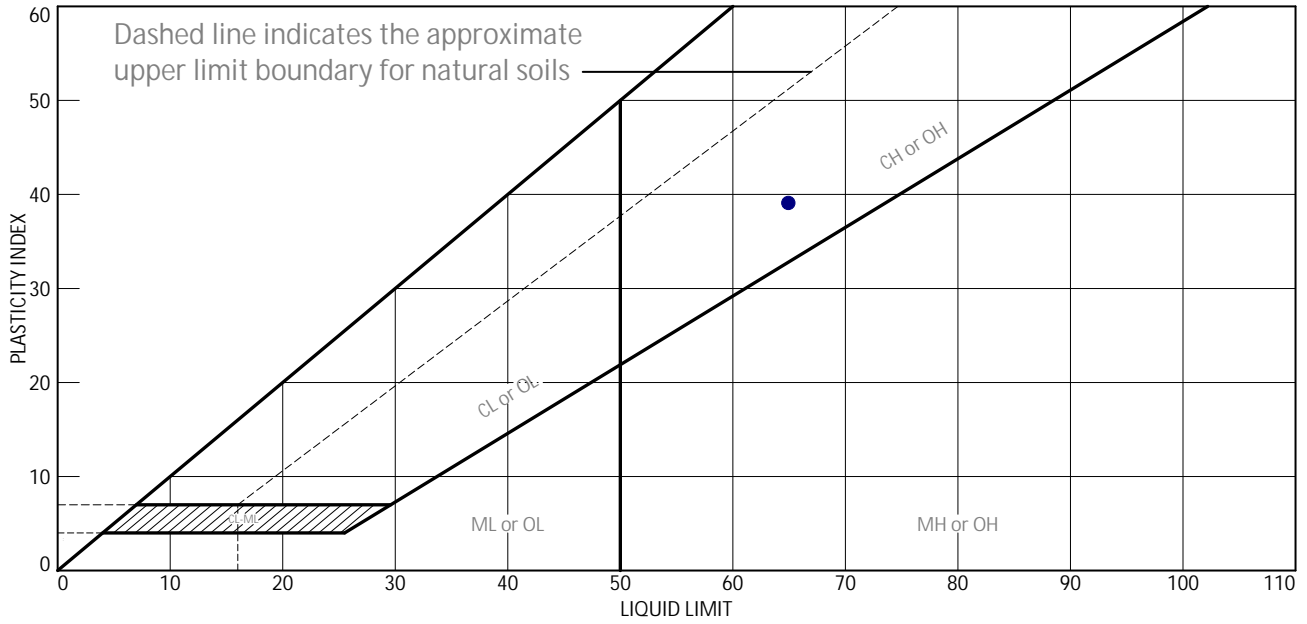
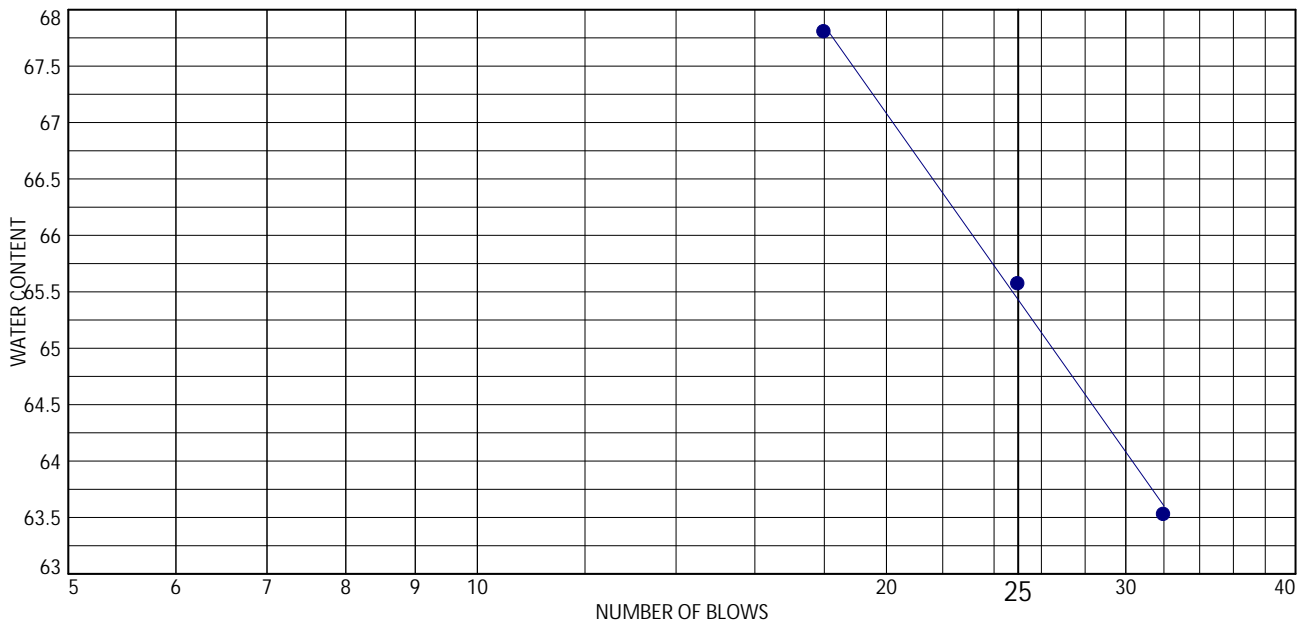
MATERIAL DESCRIPTION	LL	PL	PI	%<#40	%<#200	USCS
● Brown and dark brown CLAY with trace sand	65	26	39			CH

Project No. 23-1415-11G Client: Monroe County Redevelopment Commission  
 Project: Monroe County Justice Center  
 Source of Sample: B-3 Depth: 1.0-2.5 feet  
 Sample Number: S-1

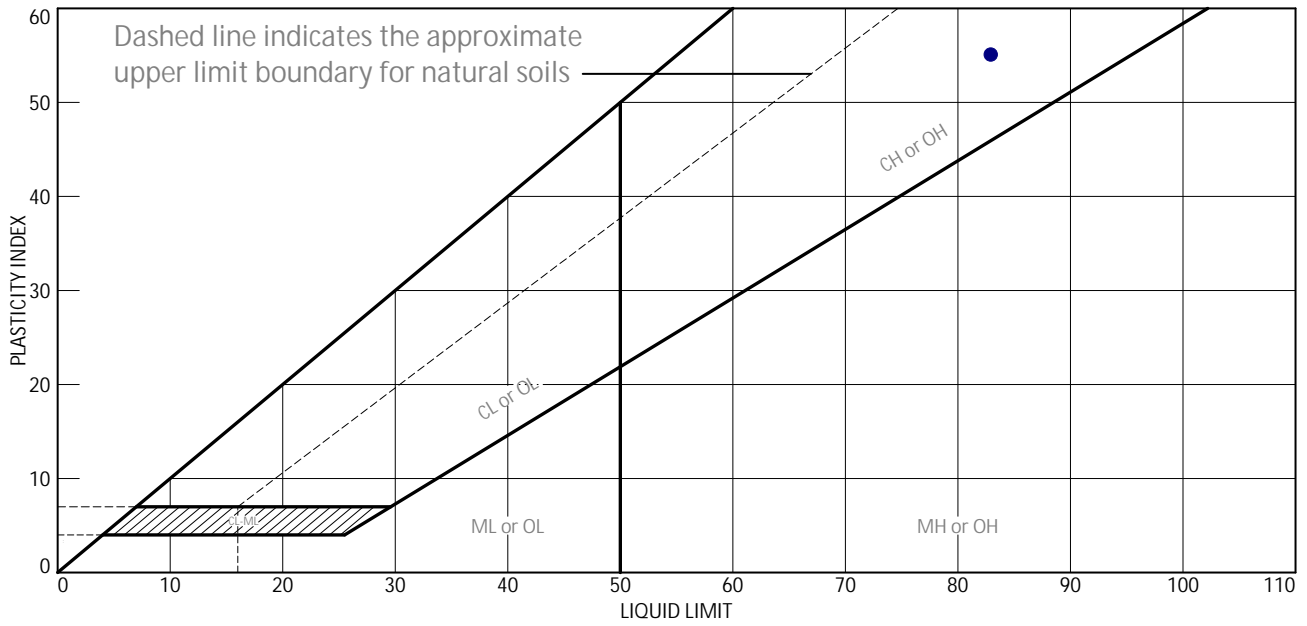
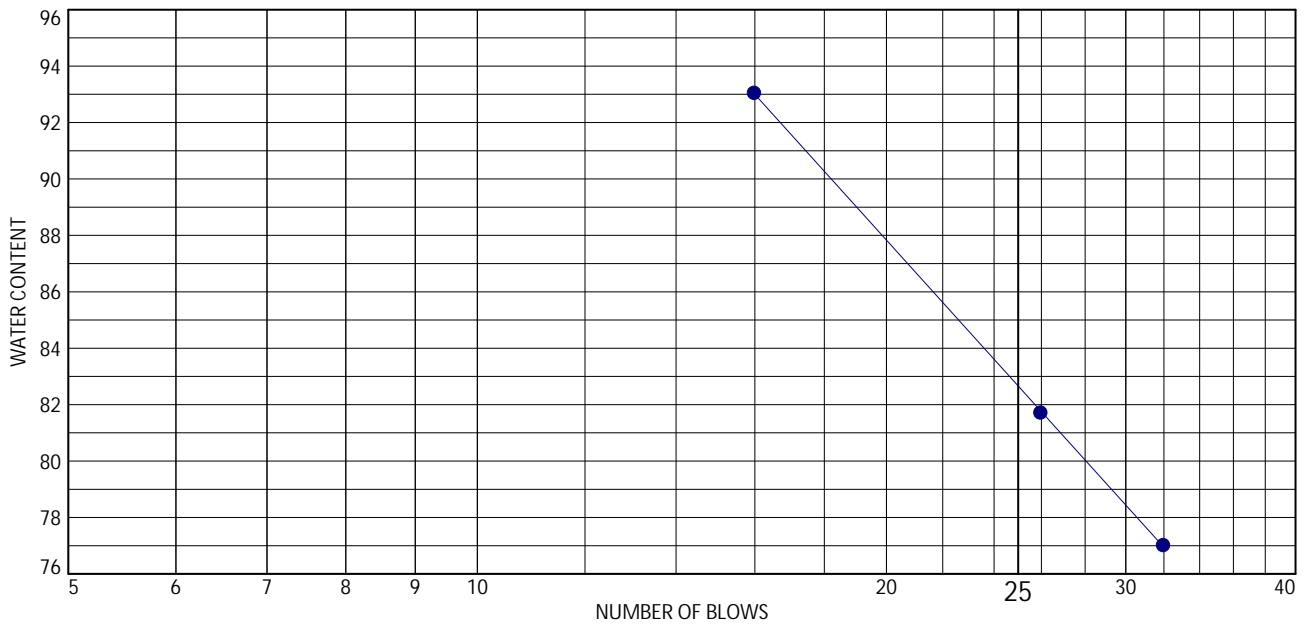
MATERIAL DESCRIPTION	LL	PL	PI	%<#40	%<#200	USCS
● Brown CLAY with trace sand	83	28	55			CH

Project No. 23-1415-11G    Client: Monroe County Redevelopment Commission  
 Project: Monroe County Justice Center  
 Source of Sample: B-3    Depth: 3.5-5.0 feet  
 Sample Number: S-2

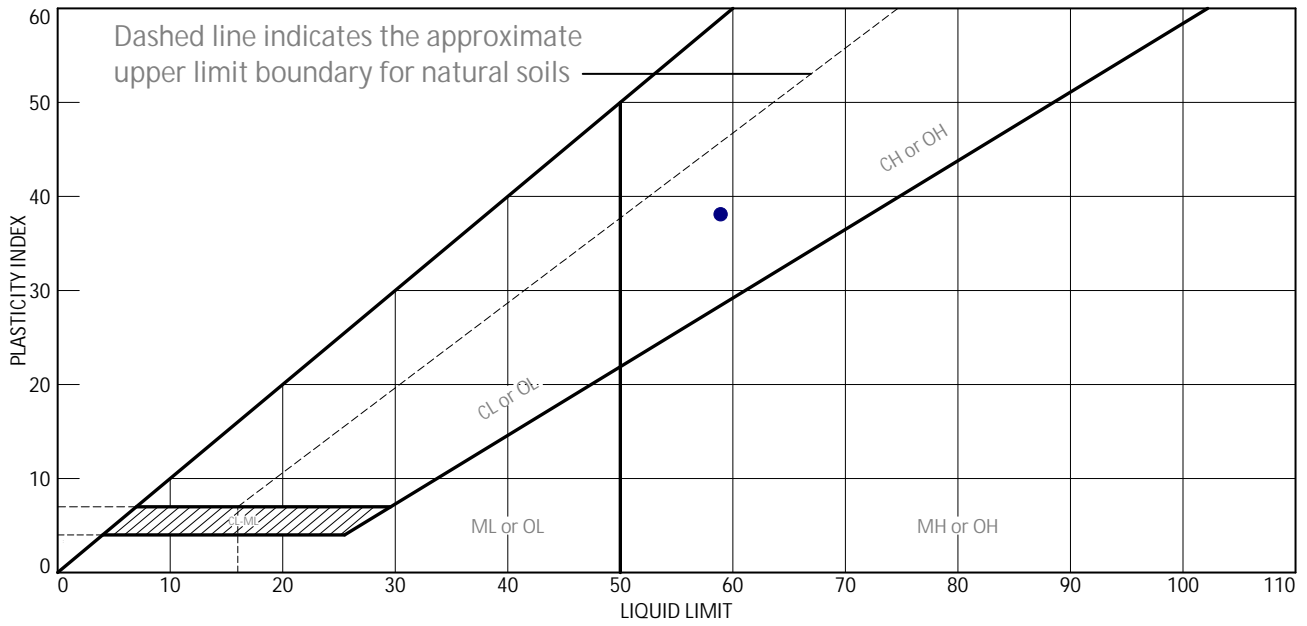
MATERIAL DESCRIPTION	LL	PL	PI	%<#40	%<#200	USCS
● Brown CLAY with trace sand	59	21	38			CH

Project No. 23-1415-11G Client: Monroe County Redevelopment Commission  
 Project: Monroe County Justice Center  
 Source of Sample: B-4 Depth: 1.0-2.5 feet  
 Sample Number: S-1

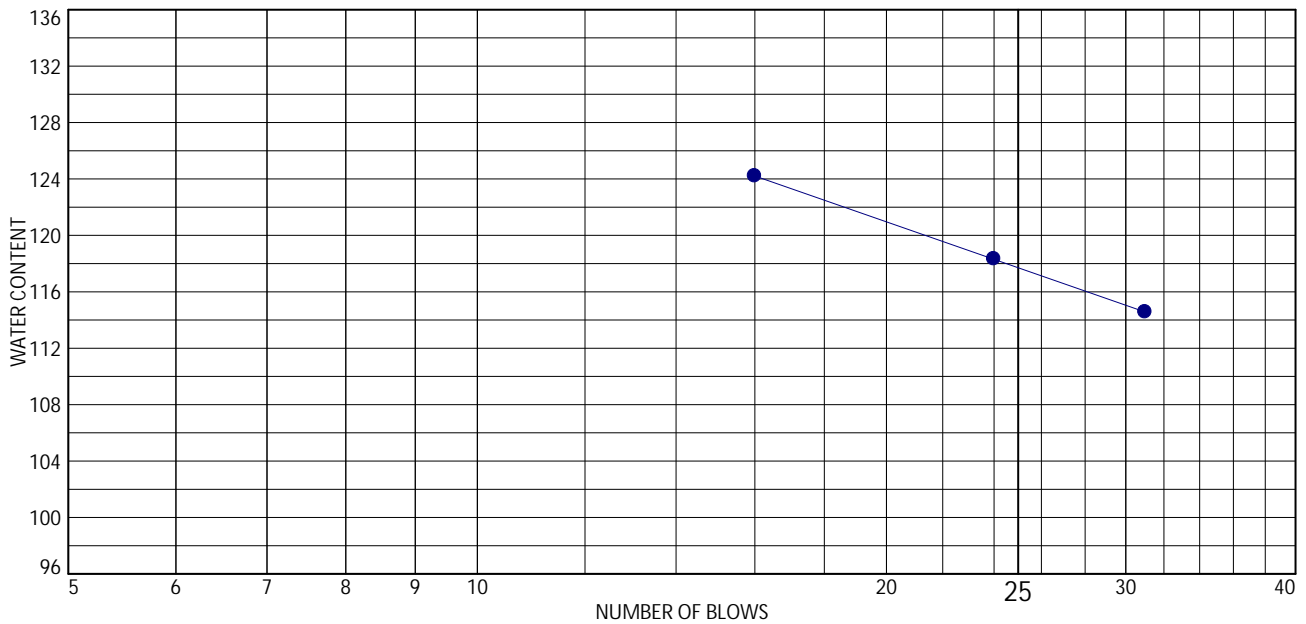
MATERIAL DESCRIPTION	LL	PL	PI	%<#40	%<#200	USCS
● Brown CLAY with trace sand	118	37	81			CH

Project No. 23-1415-11G Client: Monroe County Redevelopment Commission  
 Project: Monroe County Justice Center  
 Source of Sample: B-10 Depth: 8.5-10.0 feet  
 Sample Number: S-4
