# **ARSEE ENGINEERS, INC.**

Johnson Creamery Smokestack  
for

March 1, 2022

Re: Johnson Creamery Smokestack  
Bloomington, Indiana

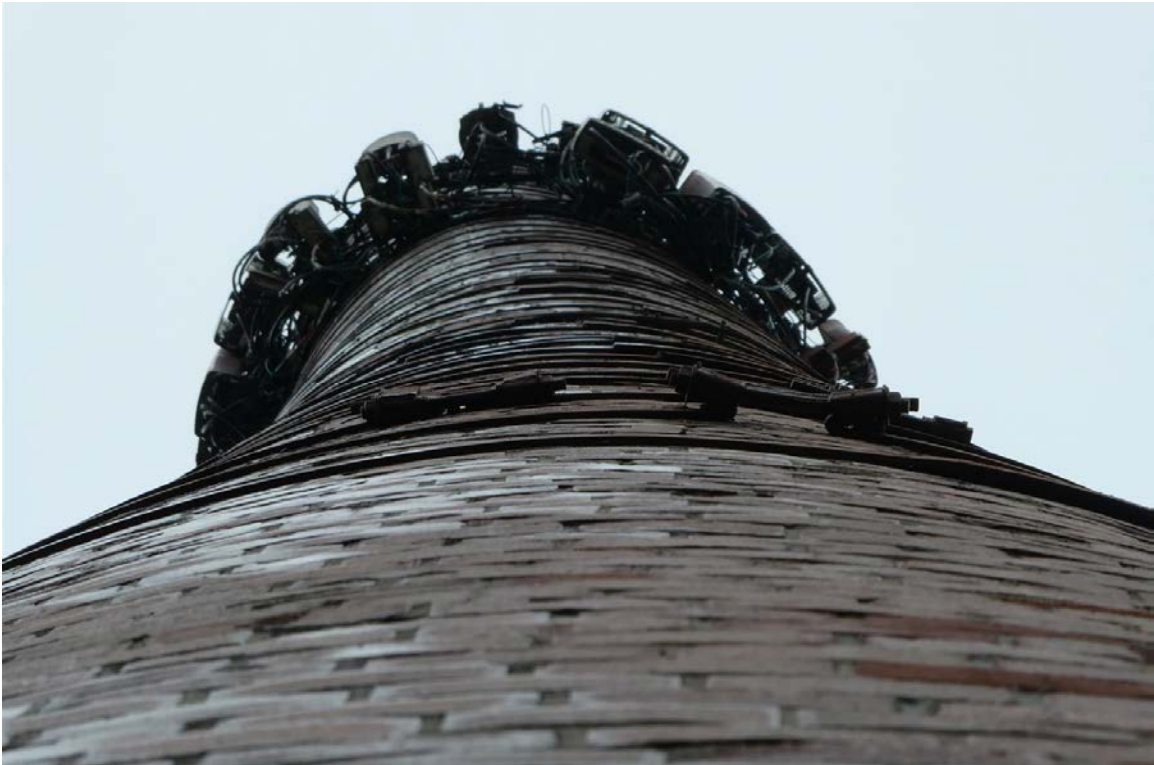
The smokestack leans or tilts to the southeast. This is severe enough that it can be seen from ground level with the naked eye as shown in Photos 1 and 2. In 2017 we determined that the top of the stack was leaning 1 foot in every 10 and estimated that the overall tilt was in the order of several feet.

Photo 1 Looking up the wall of the stack on the southeast face.

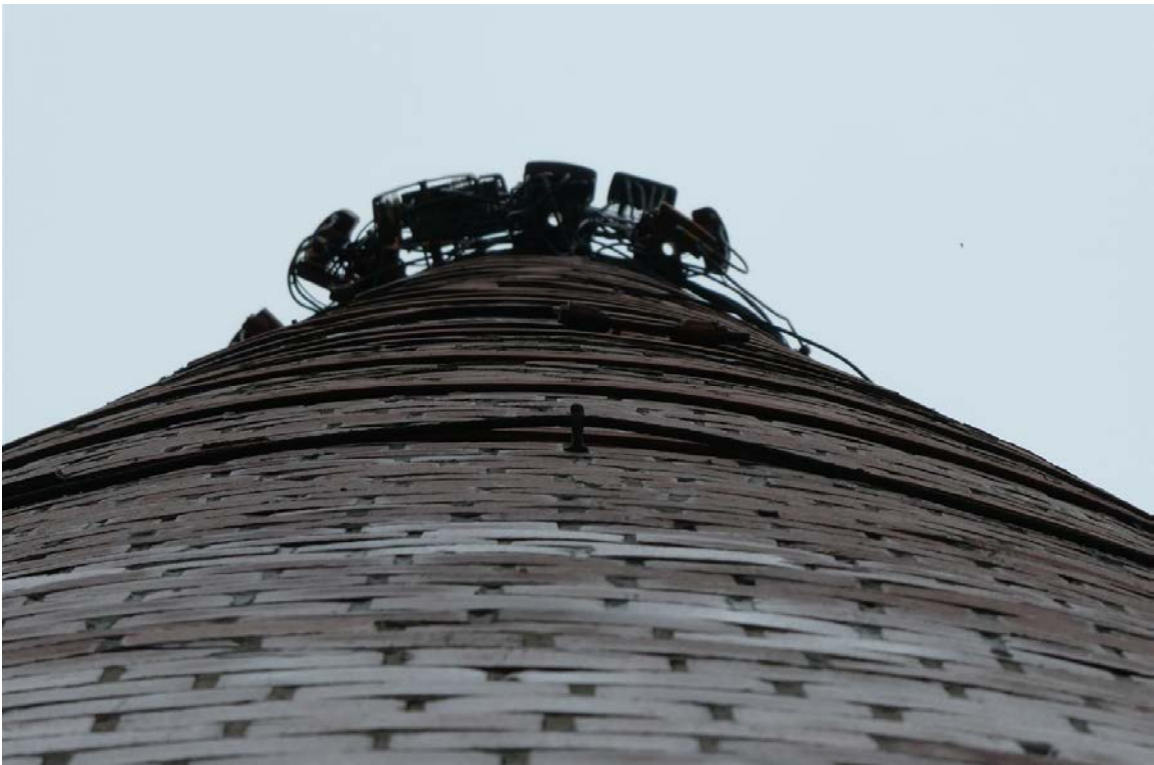
Photo 2 Looking up the wall of the stack on the opposite side as Photo 1.

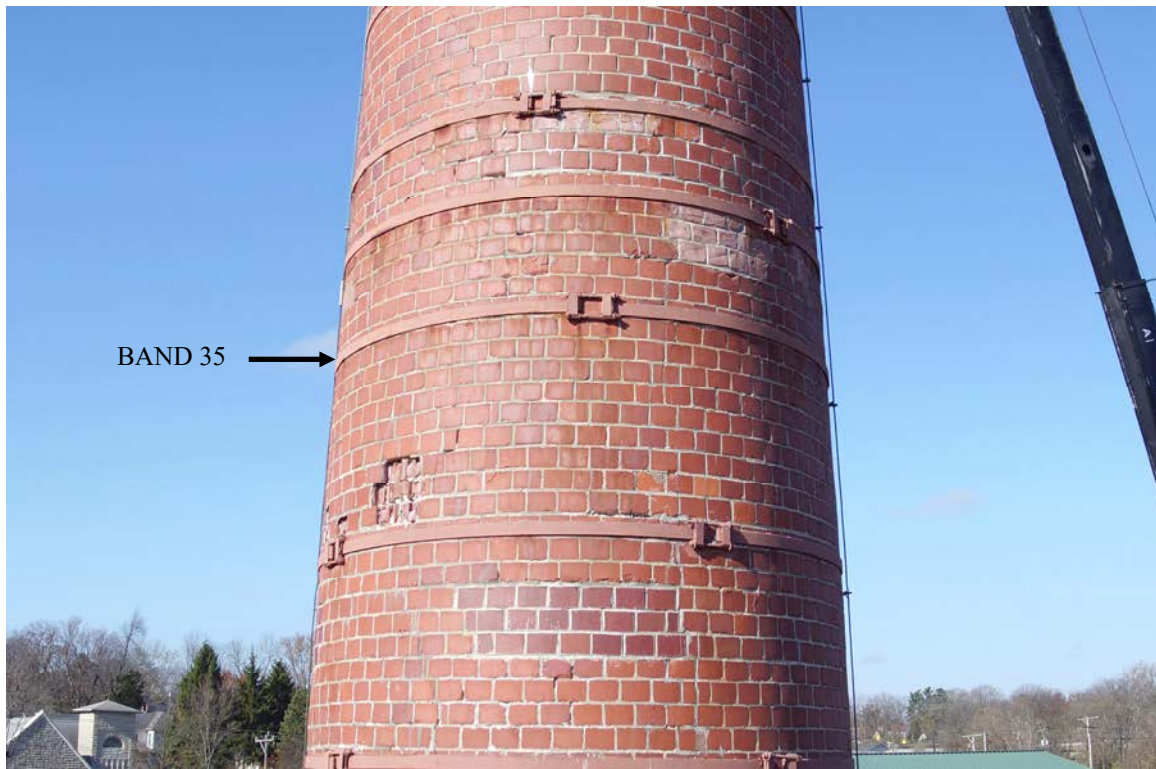
Photo 3 Photo taken in 2017.

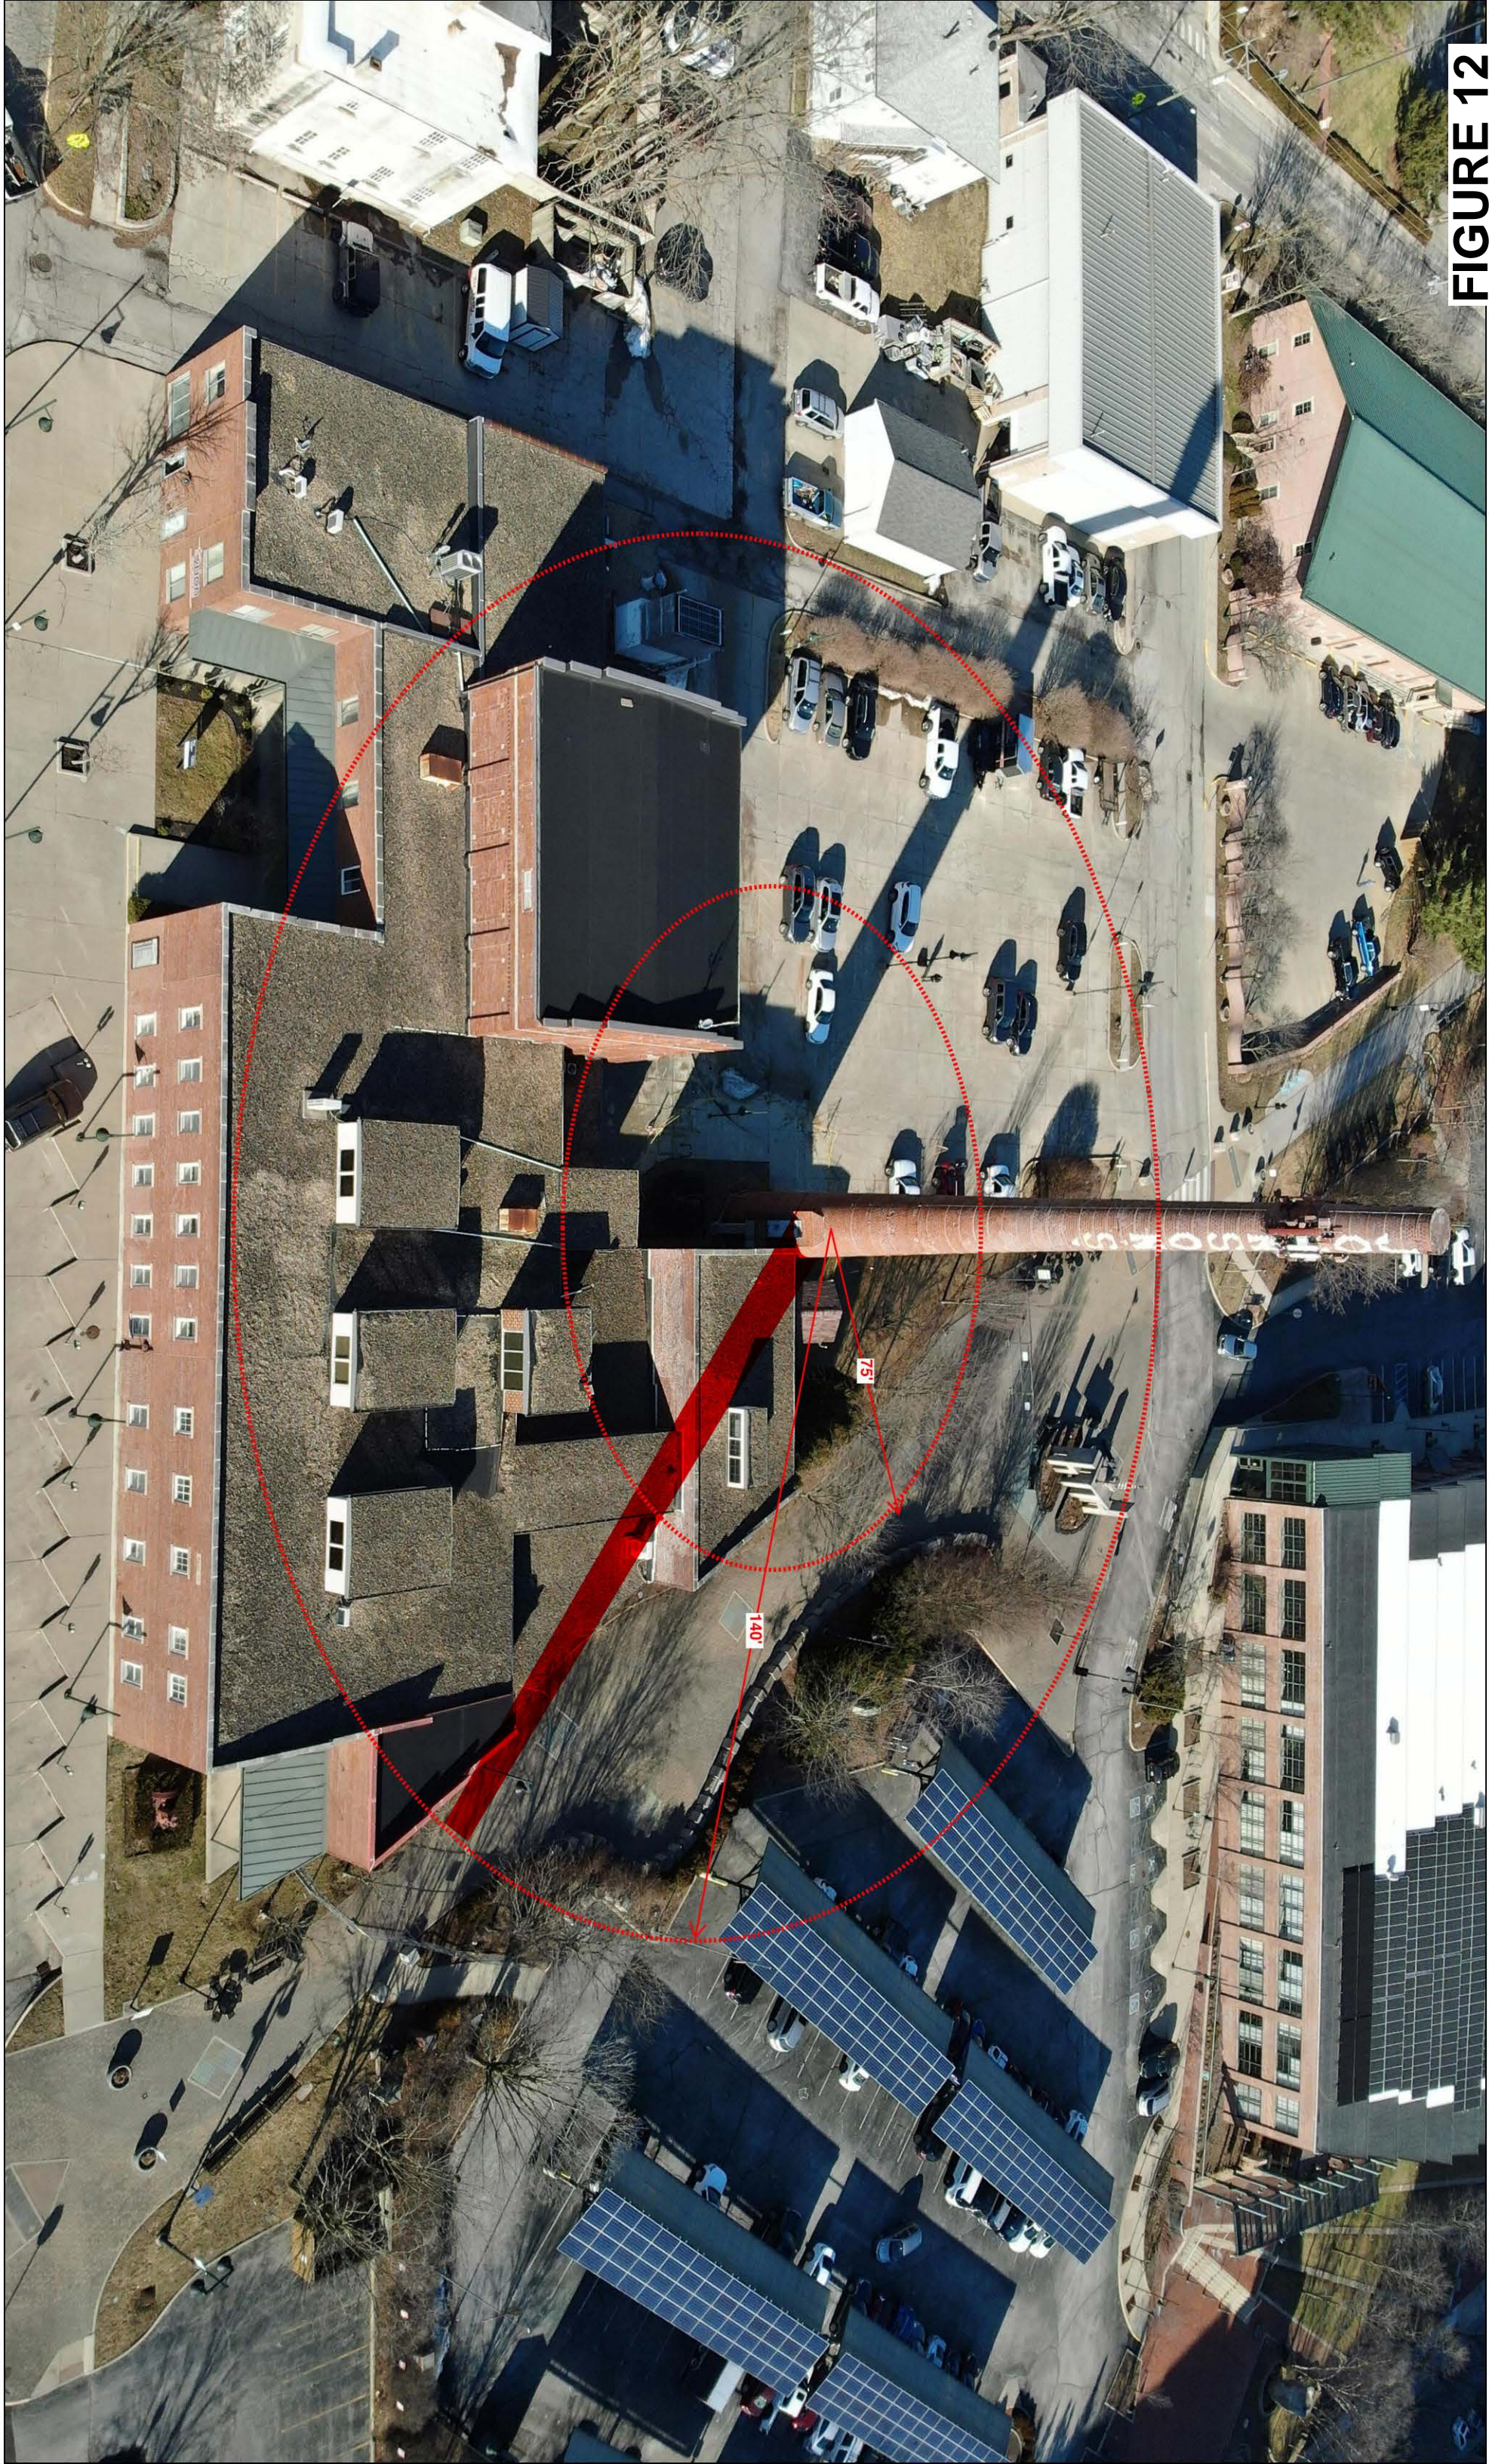
FIGURE 12

ASSUMING THIS IS AN ANOMALY, THE TOP OF THE FOUNDATION TILTS DOWN TO THE SOUTHEAST APPROXIMATELY 1".

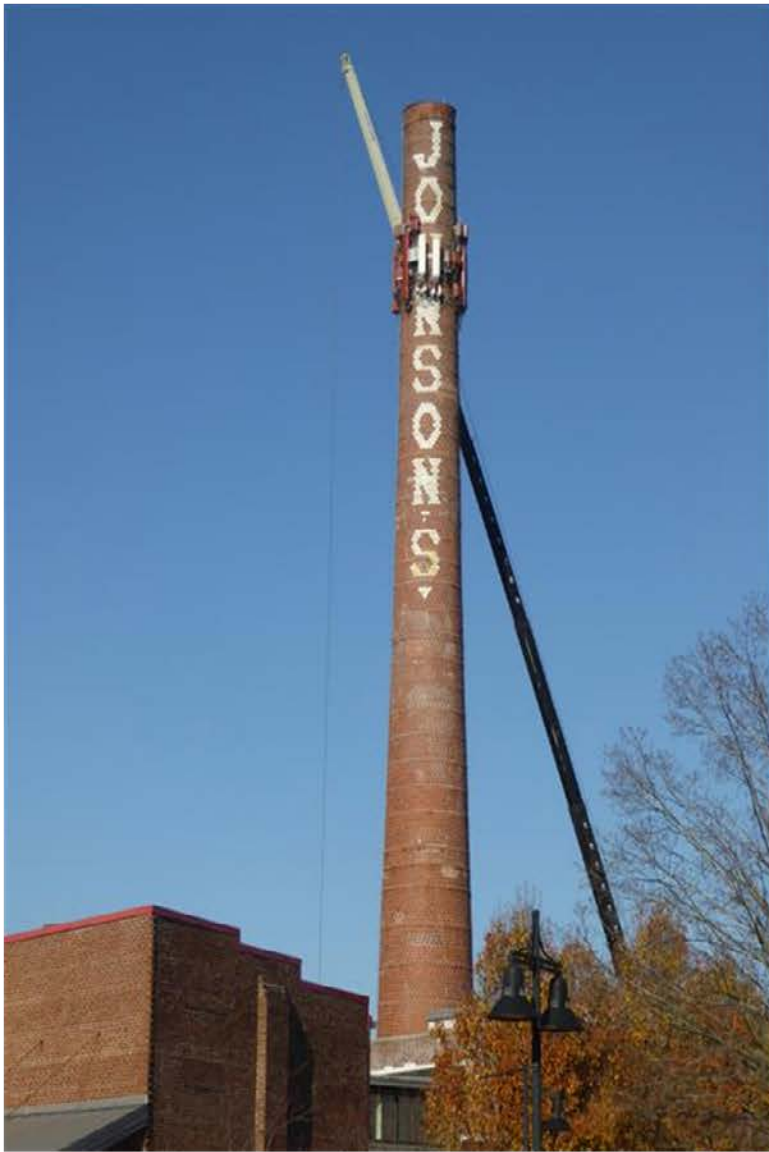
Photo 1

Overall view from the southeast.

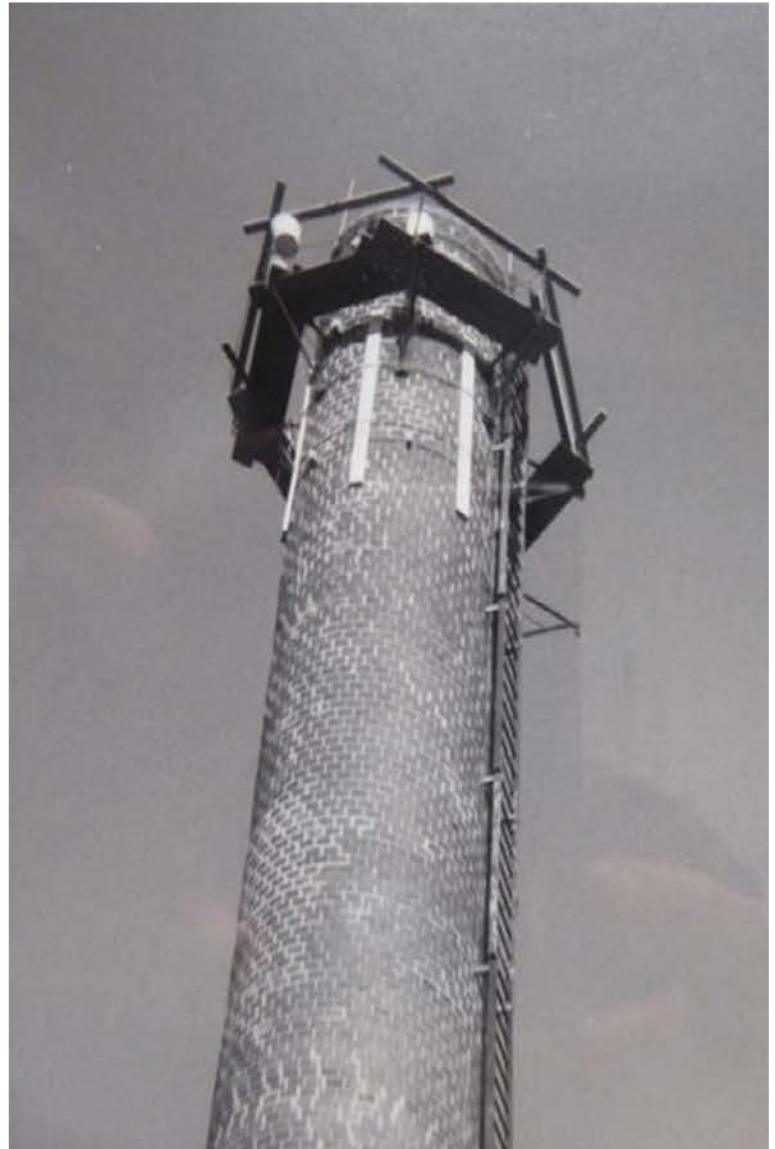
Photo 6

...and several bands have been installed at the top. The “larger” white mortar joints have been tuckpointed.

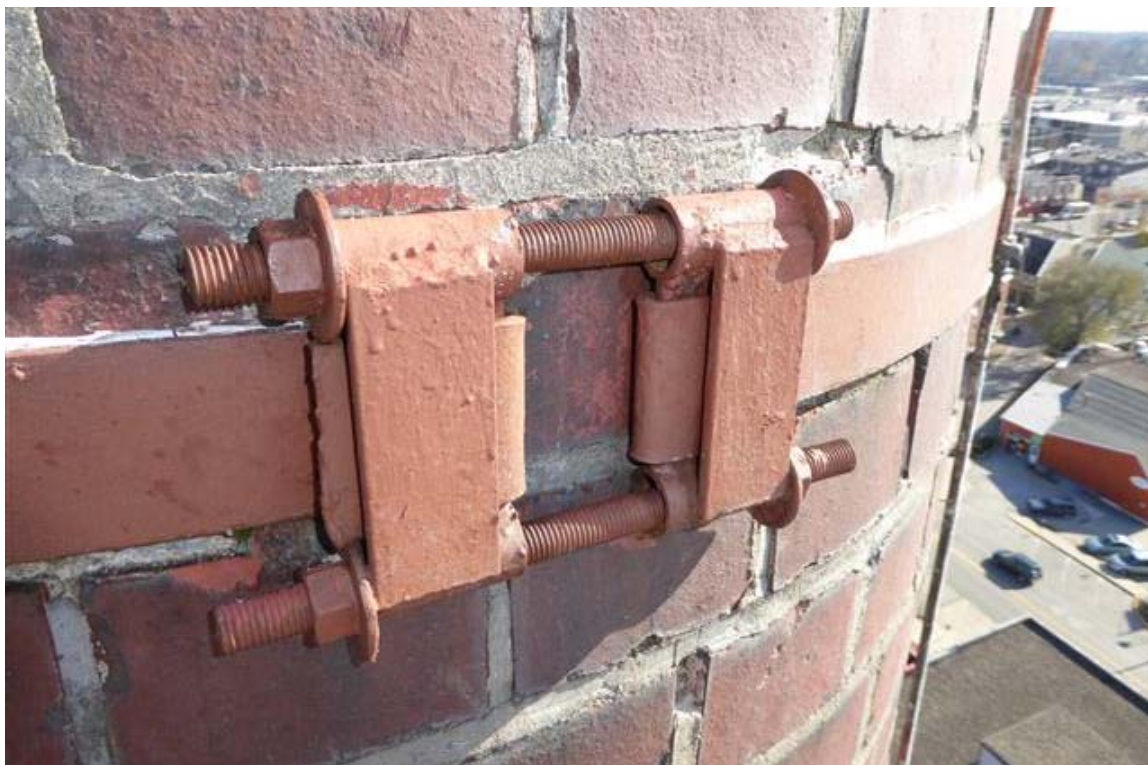
Photo 10

The 1/4 x 4 inch steel bands are secured with two, 3/4 inch diameter bolts.

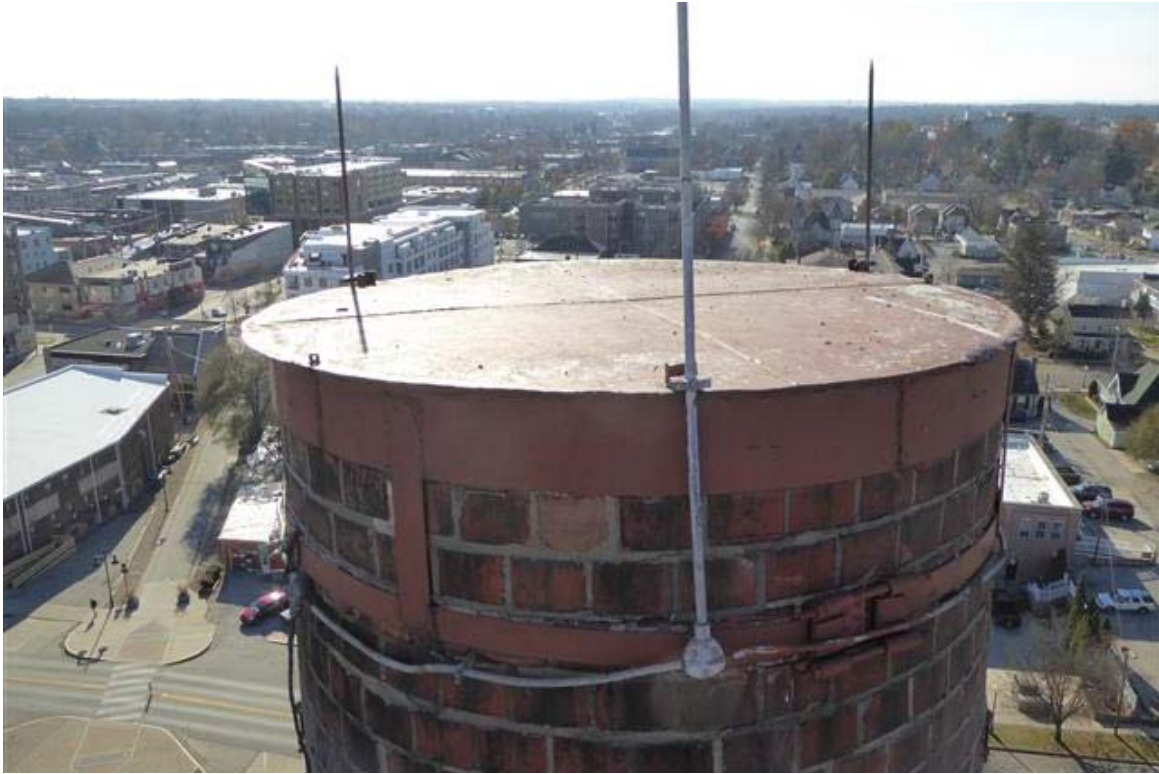
Photo 11 The top of the stack has been capped with a steel plate.

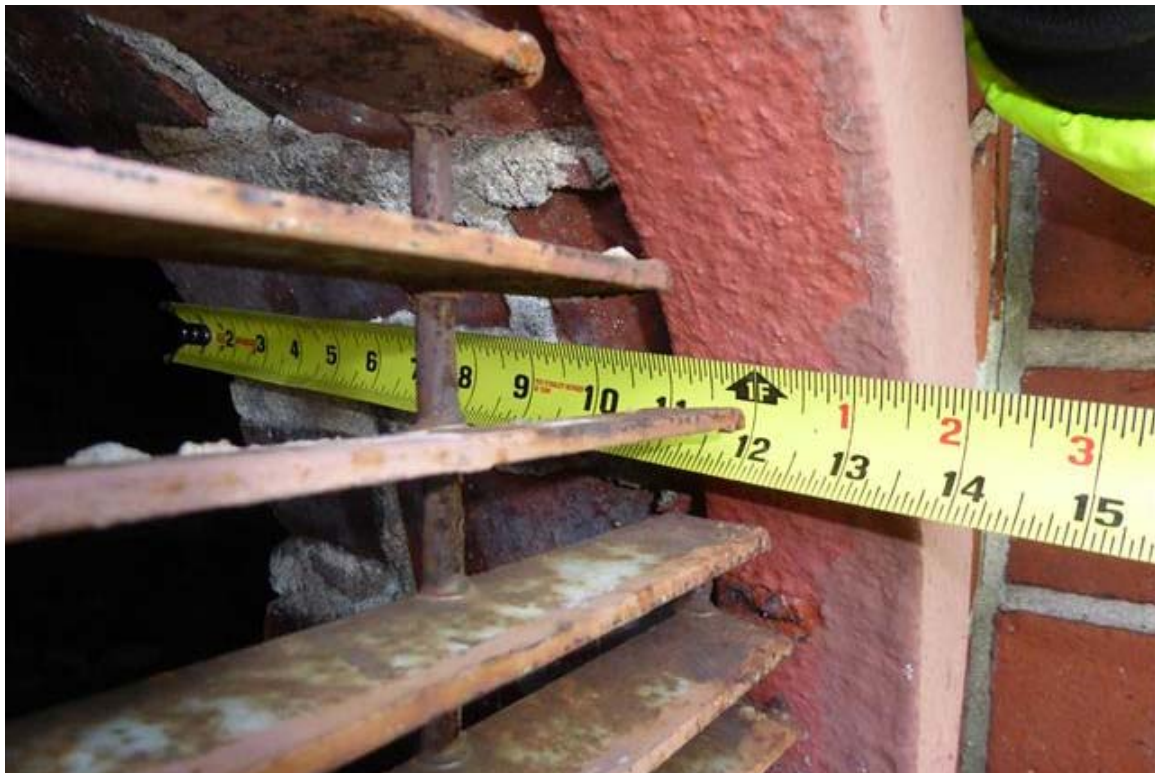
Photo 14 Wall thickness at the opening is 13 inches or 3 wythes of brick. This flares out to 5 wythes of brick or 20 inches in thickness on the sides of the opening.

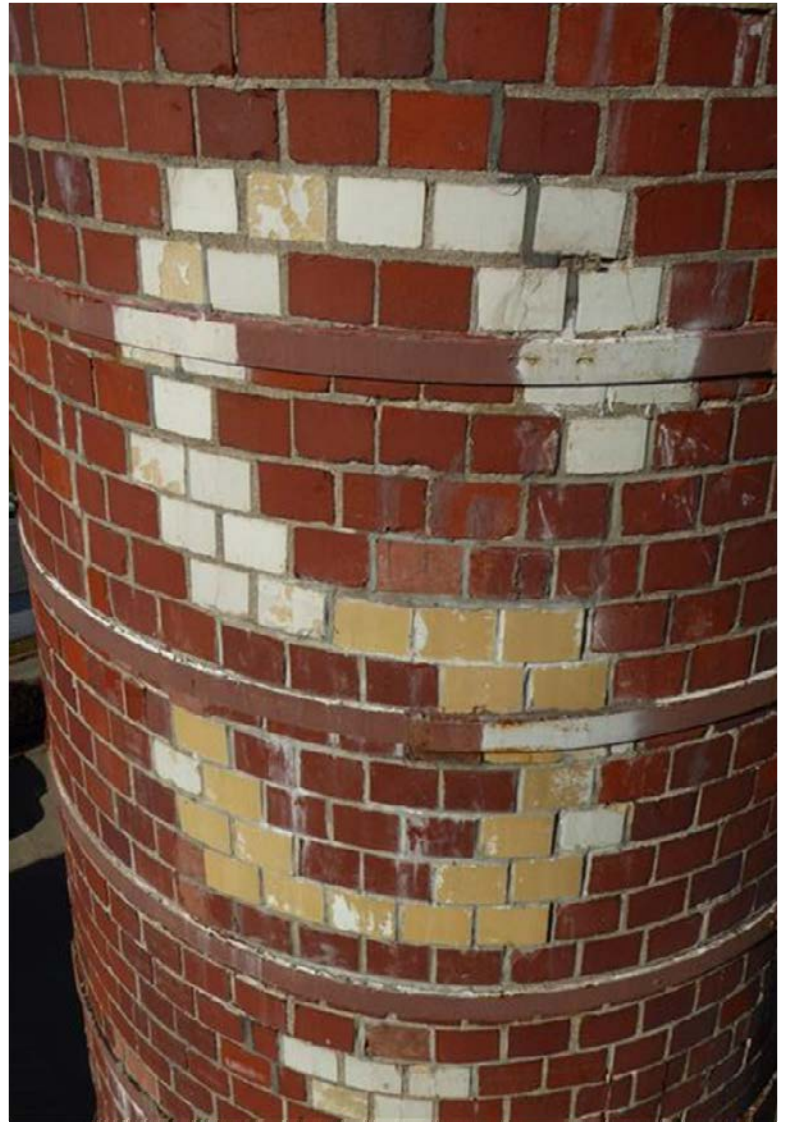
Several of the glazed tile in the “S” were replaced.

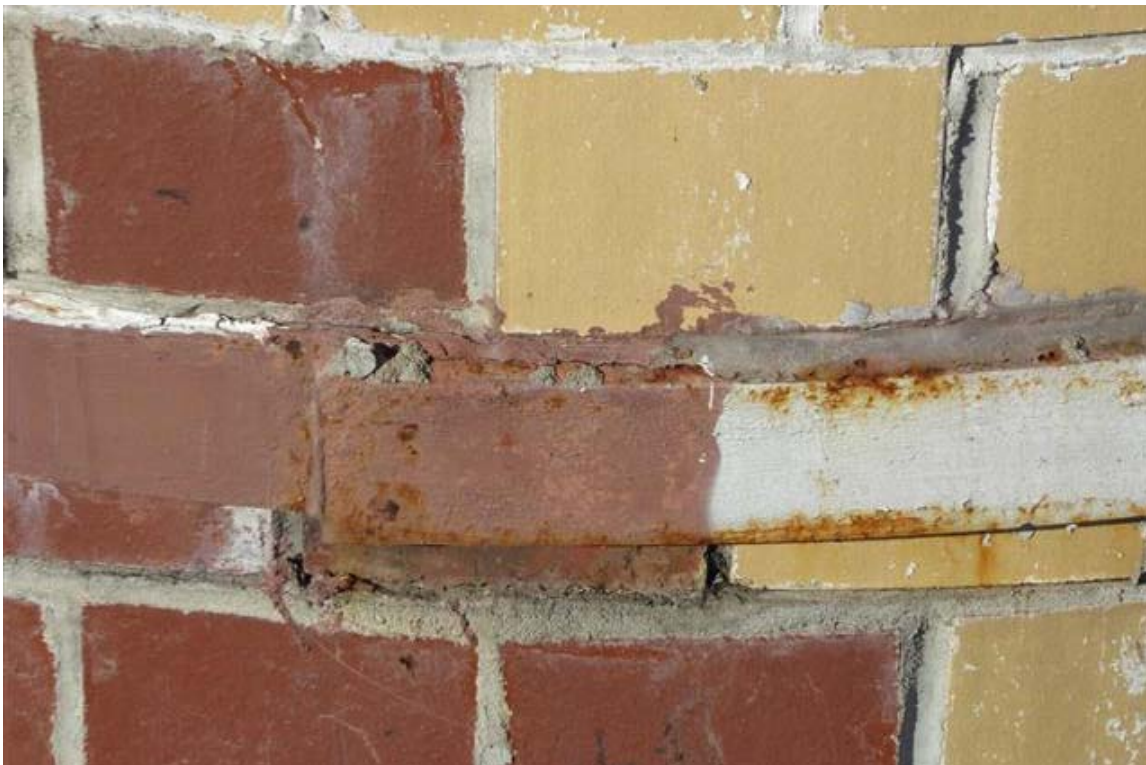
Photo 28

This occurred prior to the steel band being placed in this location.

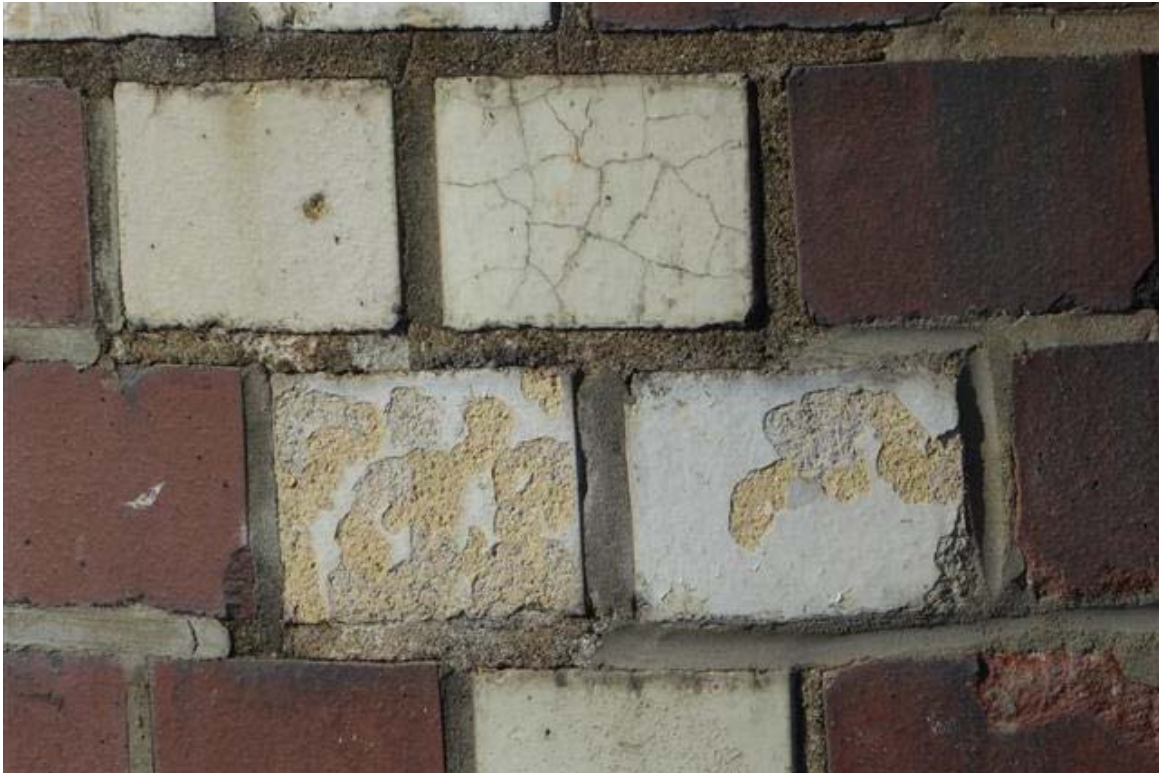
Photo 29 Glaze spalls continue to occur.

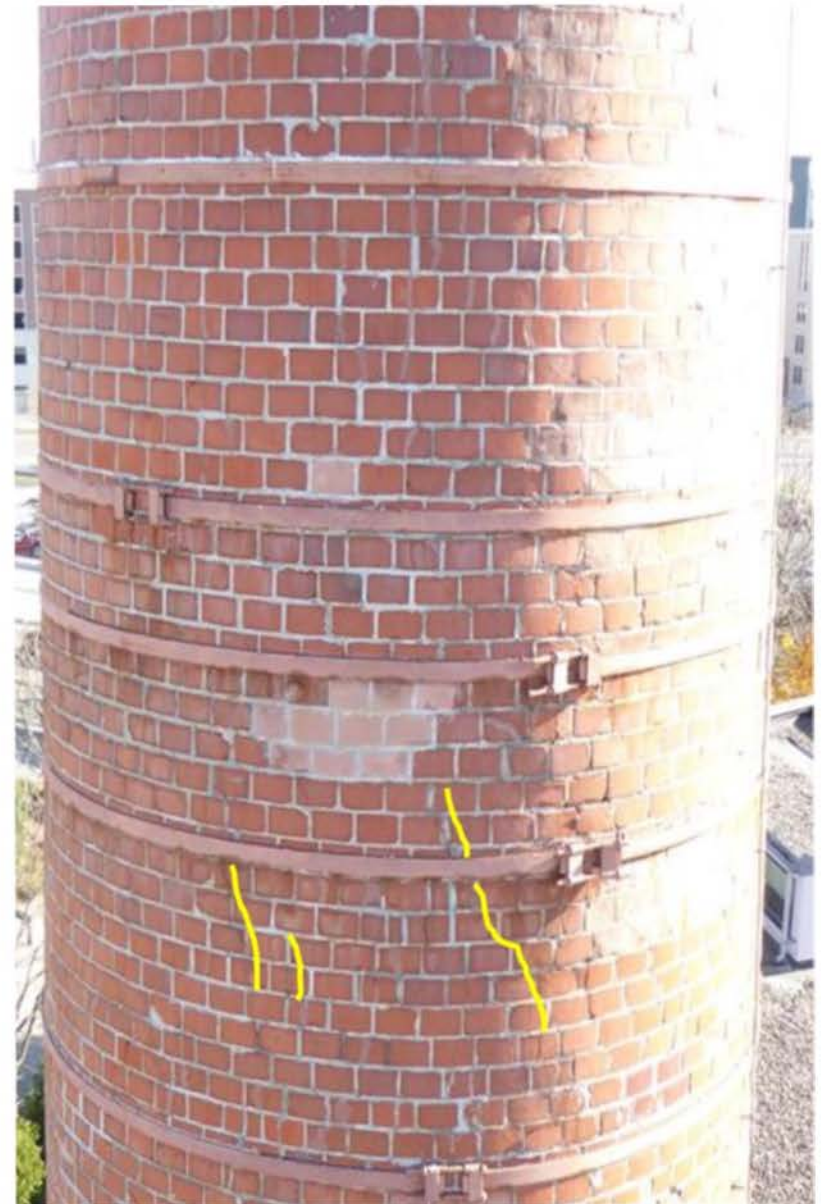
Photo 32

Tuckpointed cracks are still visible today AND many more cracks/spalls have occurred.

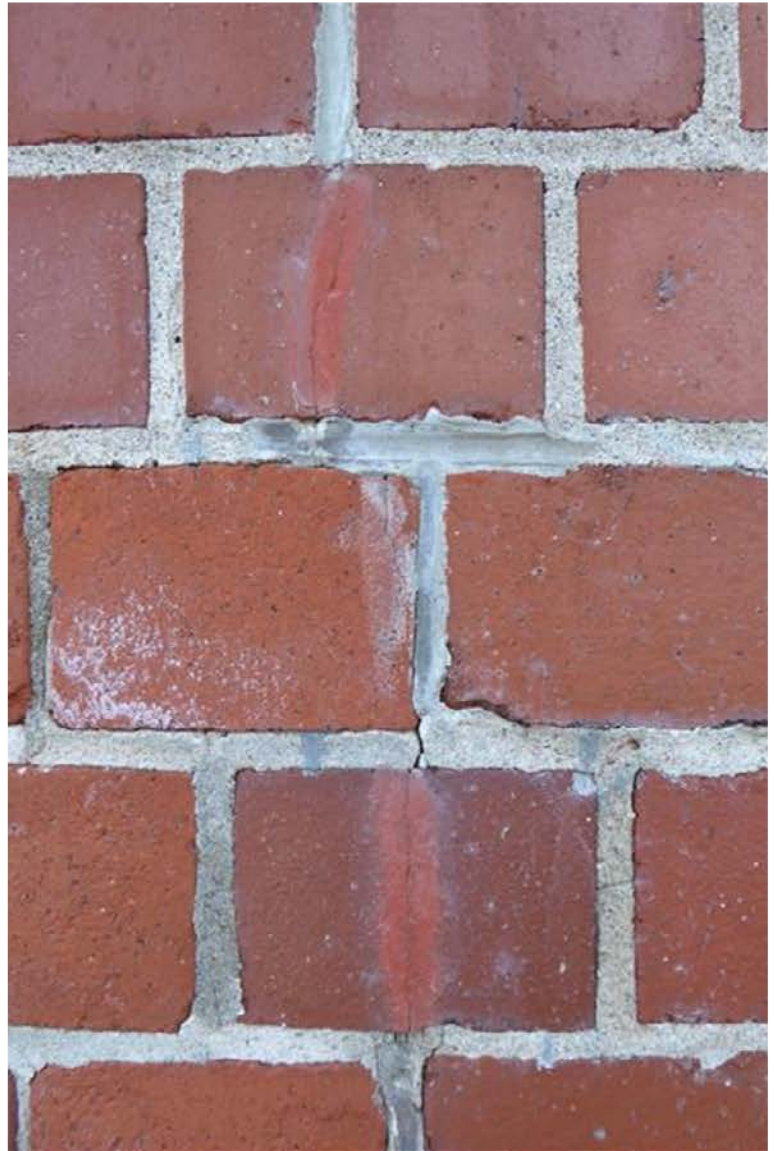
Photo 37

Unrepaired cracks lower in the stack...

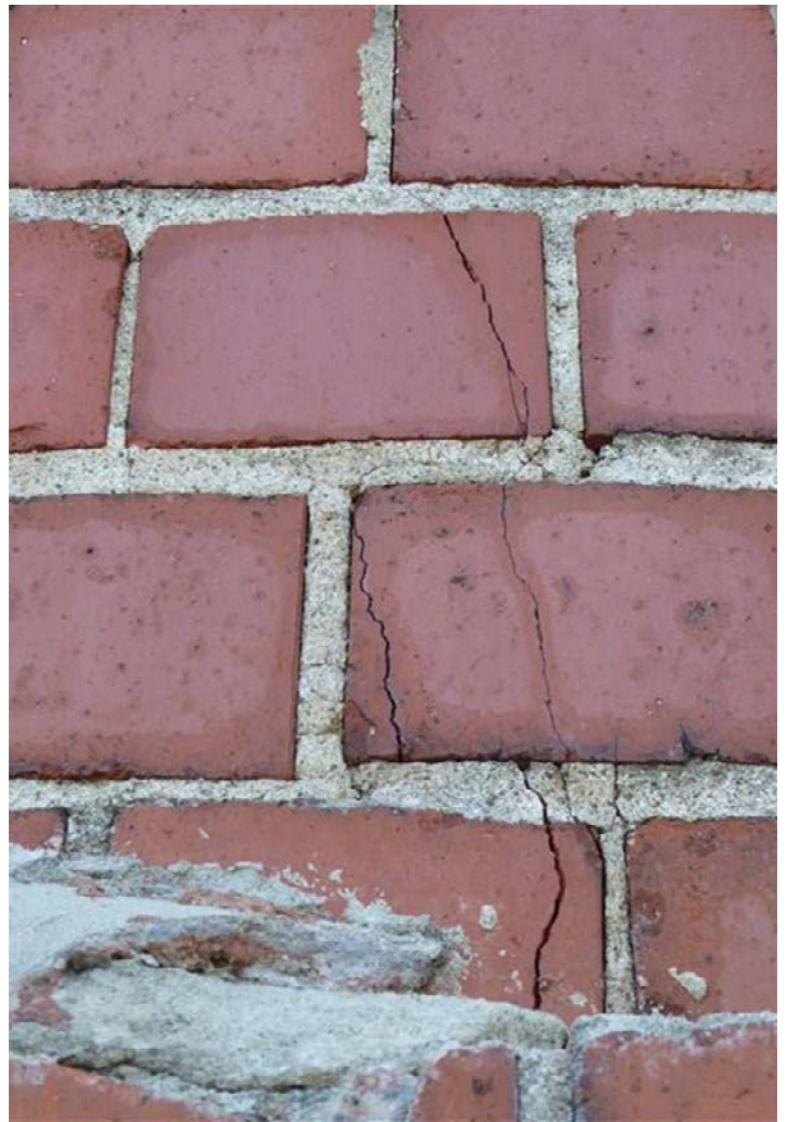
Photo 38

...and near the top of the stack.

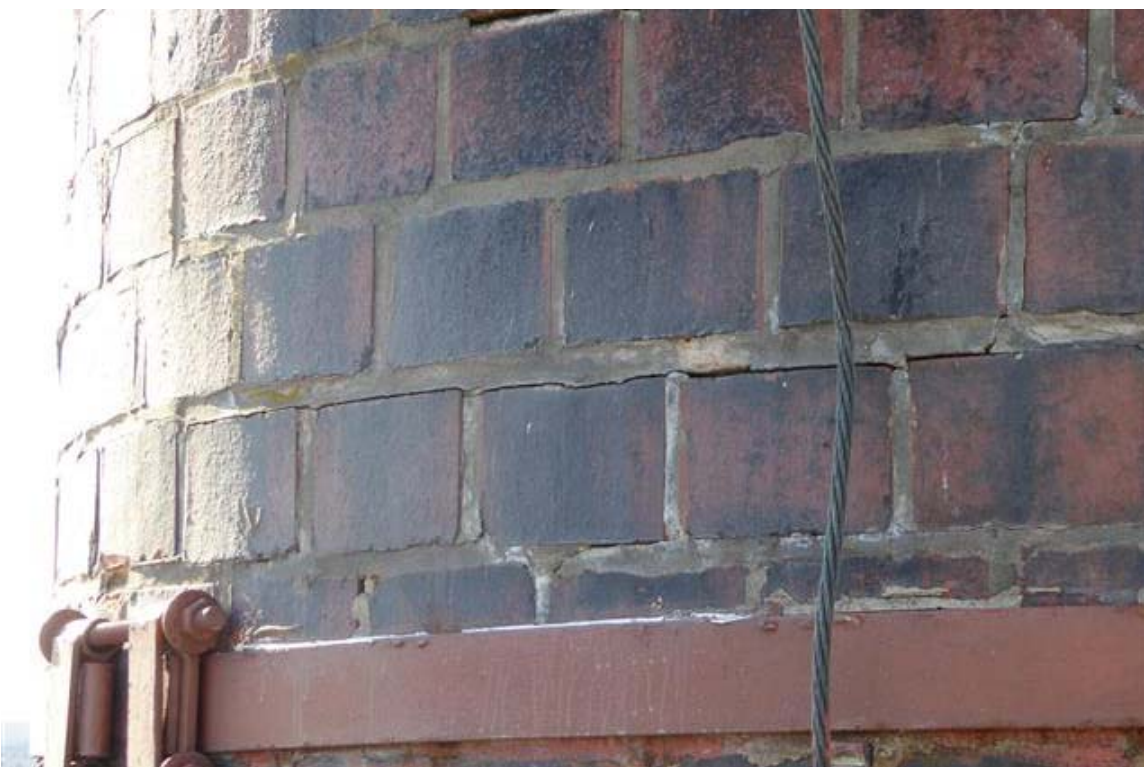
Photo 39

Tuckpointing mortar falls back out of the joints in multiple locations.

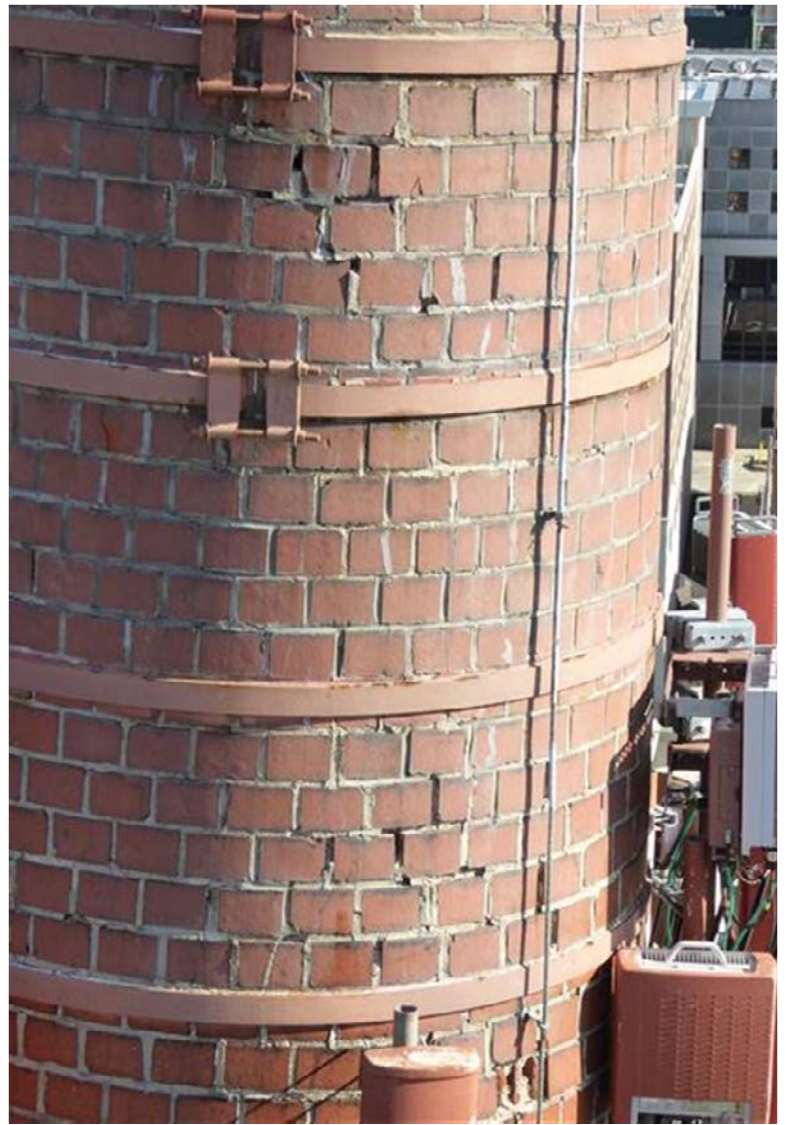
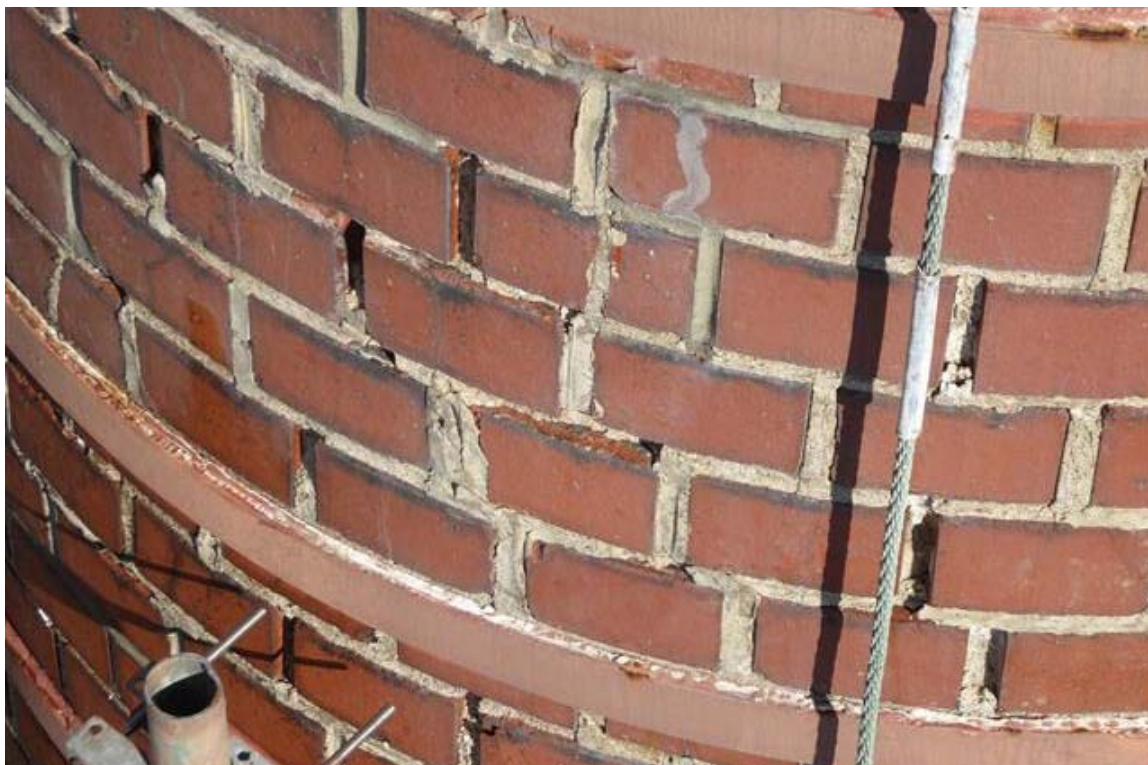
Photo 40

Closer view of one such area.

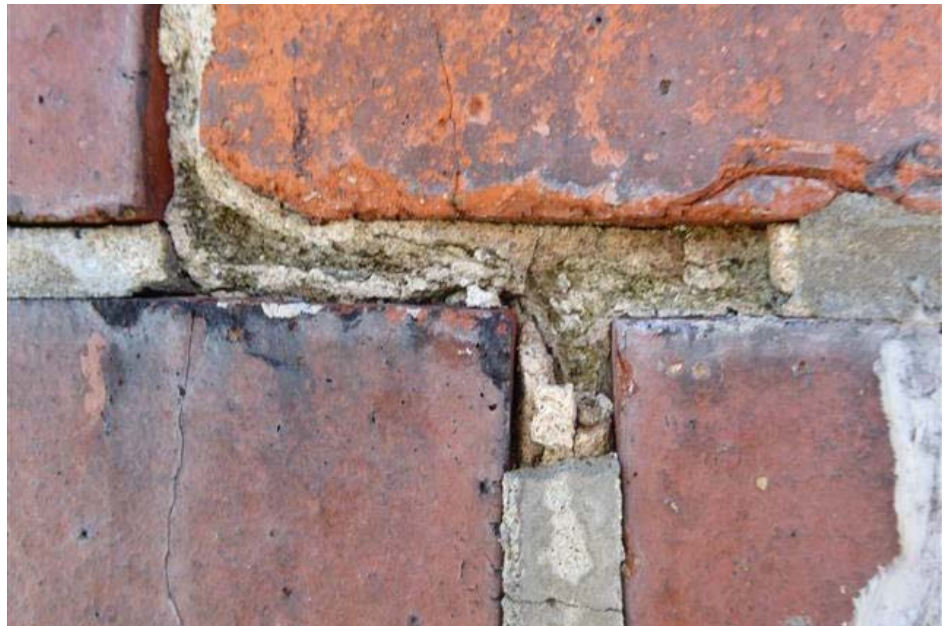
Photo 43B

Similar condition in another location.

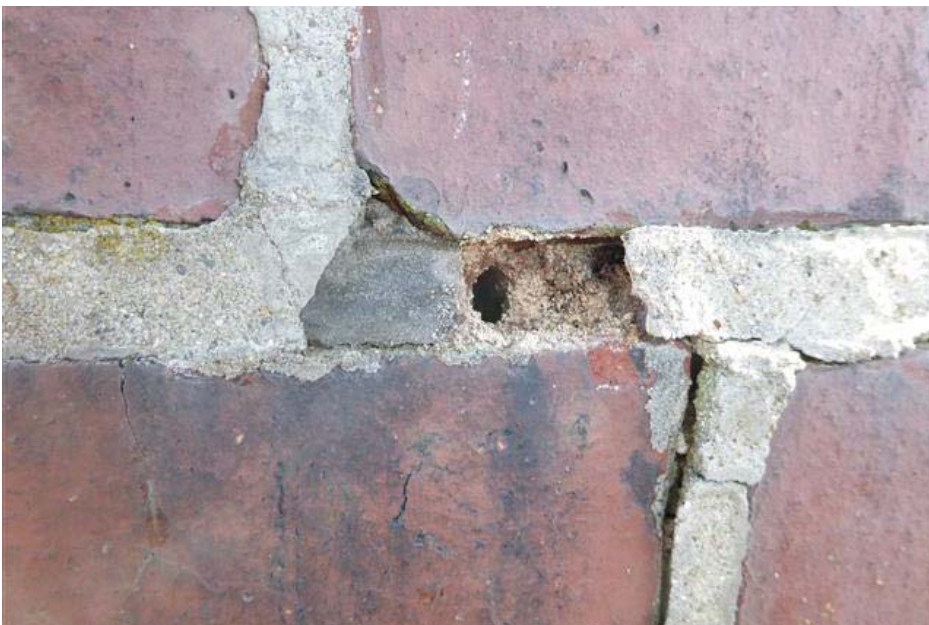
The original mortar is much softer than the tuckpointing material when drilled.

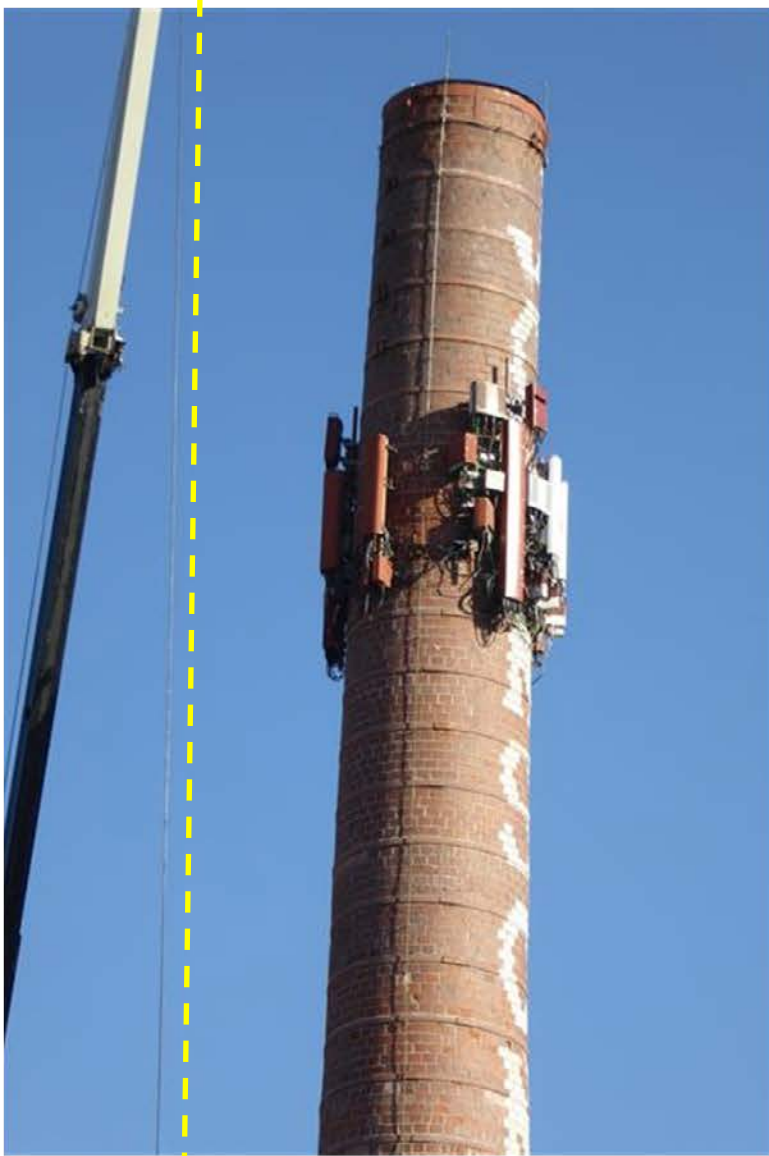
Photo 44

- New (unrepaired) cracks were observed. These occur throughout the height of the stack.
- The stack visibly leans to the south as shown in Figure 6 and Photos 44 through 47. Multiple reports indicate this condition has been present for a long period of time. Plumb bob measurements found the top of the stack is out of plumb at a slope of 1 to 10 or approximately 6.0°.

The crane wire serves as a giant plumb bob...

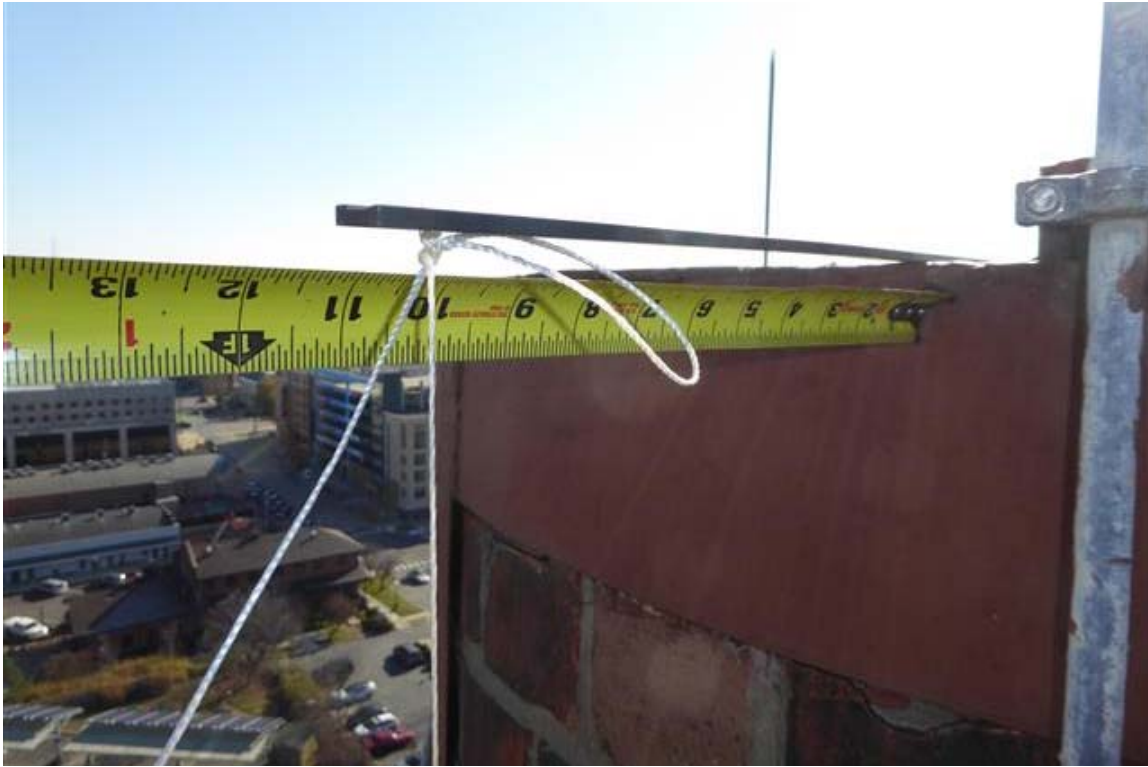
Photo 46

Measurements taken above the cell phone equipment revealed the top of the stack leans 10 inches in 90 inches.
